Steel Mill Valve Repair

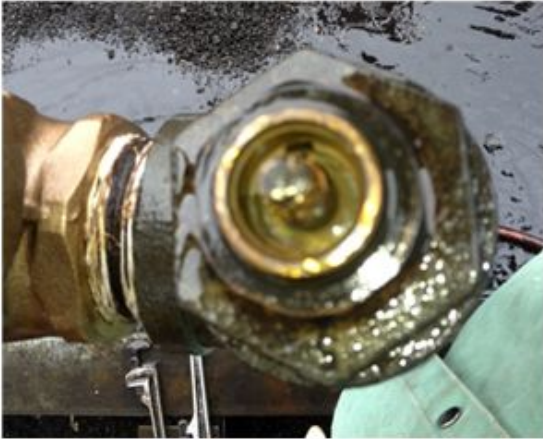
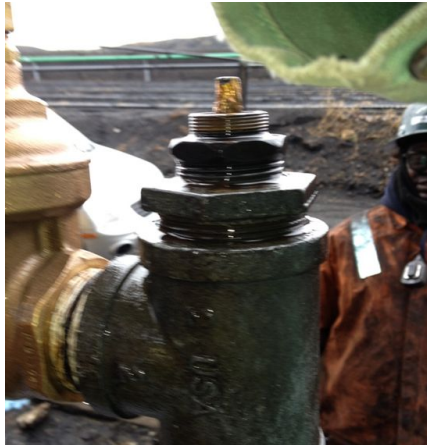
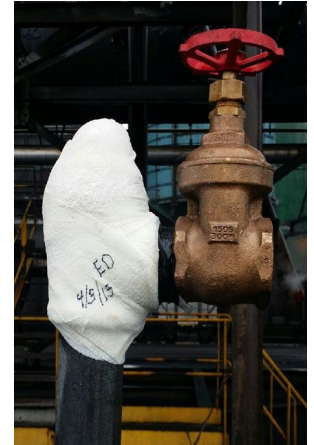
A Steel Mill was experiencing a leak in one of their coal handling valves. The water was leaking out of the top and they were not able to stop it. They contacted the USI Team for a fast, long-lasting solution so that they could avoid unscheduled downtime and major water costs.

First the USI Team released some of the pressure from the valve to do the repair. Then we compressed the RESIMETAL 105 Aqua Stick into the top of the valve to stop the leak. After the leak was stopped, the entire valve was wrapped in RESIMETAL 108 Pipe Repair Tape. Once cured, pressure was restored, and they were very impressed with the ease of application and the results the repair provided. This Steel Mill saved over \$100,000 in downtime, as this solution helped them to avoid an unscheduled down day.
