TANK - Floating Roof Repair

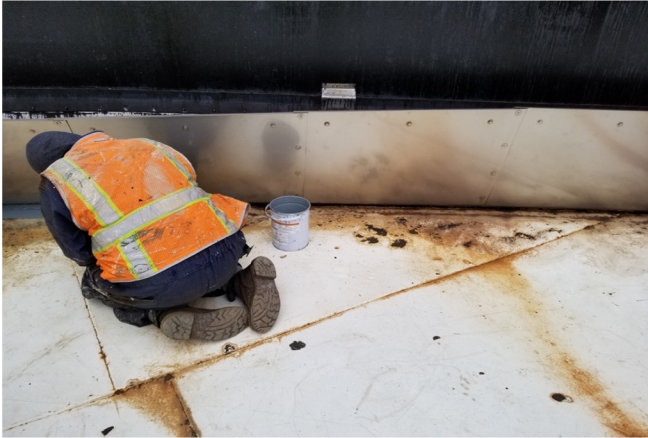
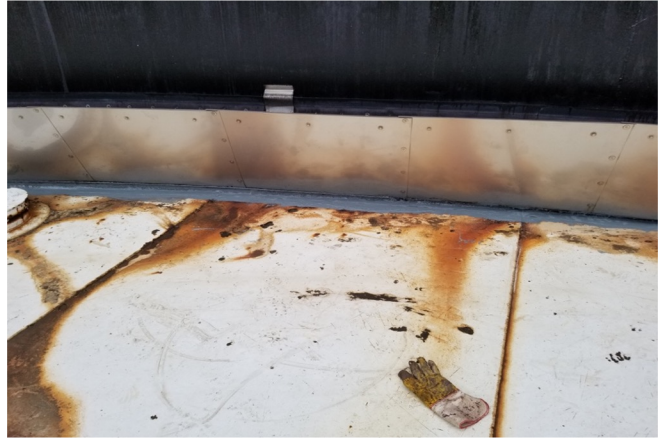
This floating roof was failing and leaking vapors into the air causing EPA issues. The customer had to decide between welding a new roof in or a make-do solutions that would need to last for two years.

The Unconventional Solutions team chose to use the high build solvent free [RESICHEM 501 CRSG](#), designed for the long-term protection of steel against corrosion and chemical attack.

All the oil and grease was removed from the surface with [USI Universal Cleaner](#). The area was then roughened with power tools, and then cleansed one more time with [USI Universal Cleaner](#) to get rid of any remaining debris.

Between the roof of the tank and the side of the tank [Resimac 101 Metal Repair Paste](#) with [Resimac 808 Reinforcement Tape](#) was used to bridge larger holes and pits.

[RESICHEM 501 CRSG](#) was used to offer corrosion resistance and then used as the glue to hold everything together. This ensures a long-lasting, protective repair.

For a complete solution and a white reflective finish, a topcoat of [RESICHEM 555 Resinox](#) was applied to provide acrylic UV protection.
