Tank Seam/Rivet Repair

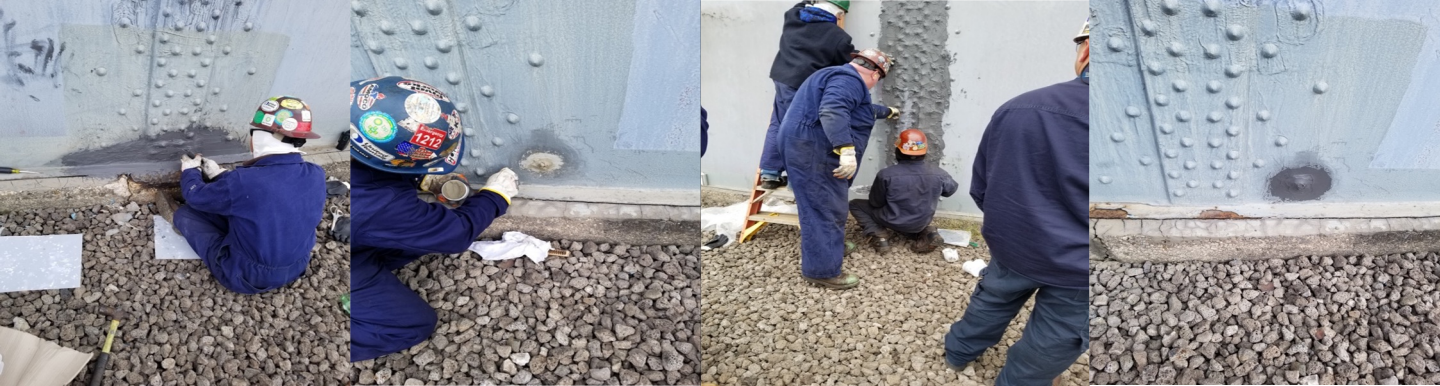
The outside of this tank had damage starting at its seams. Rust and erosion had started, and the tank needed a repair instead of a full replacement. The Unconventional Solutions team had just the right solution for this issue.

First the area needed to be surface prepped by removing all oil and grease with [USI Universal Cleaner](#).

Then the area was roughened and [RESIMETAL 104 XF Metal Repair Fluid](#) was used to stop oil seepage.

The area was cleaned once more with [USI Universal Cleaner](#) to get rid of any remaining debris.

Then the [RESIMETAL 101 Metal Repair Paste](#) was mixed according to the technical data sheet, applied, and pressed firmly over top of [RESIMETAL 104 XF Metal Repair Fluid](#). This method provides additional strength as well as reduces or eliminates all possible air pockets to ensure excellent product adhesion and a long-lasting repair.
