## Sugar Mill Juice Plate Heat Exchanger Rebuild

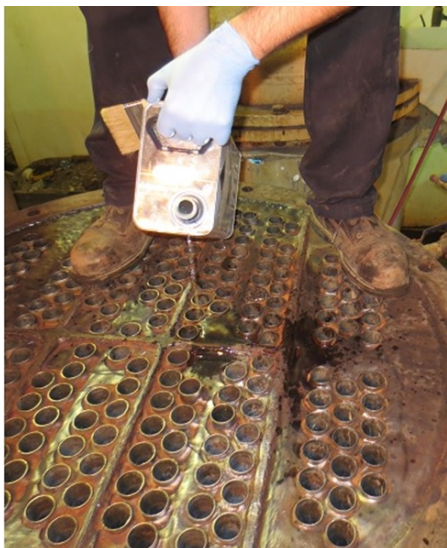
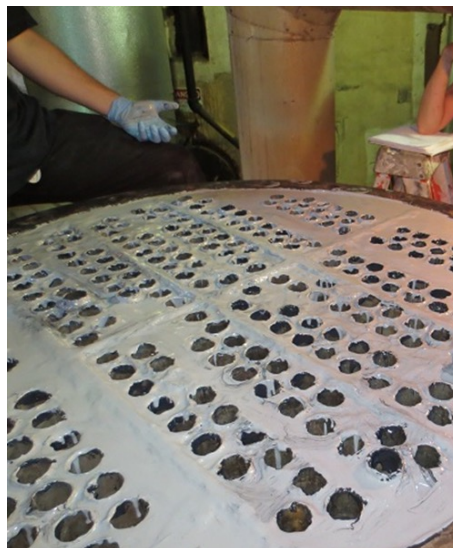
This sugar mill needed a solution for their press water heater. The area around the tubes had a ¼" to ½" of missing metal on the face plate of the heater and was getting worse.

First the area was cleaned with [USI Universal Cleaner](#).

Next the [MBX Bristle Blaster](#) was used to create a 2 ½" – 3" anchor pattern around the tubes where there was missing metal.

Then the USI Team used [RES201 Ceramic Repair Paste](#) to build up the areas around the tubes.

After allowing cure time for this material, 2 coats of [RES205 Ceramic HT Fluid](#) was applied. This product is designed for up to 300°F continuous emersion.
