## Vertical Inline Pump for Cooling Tower

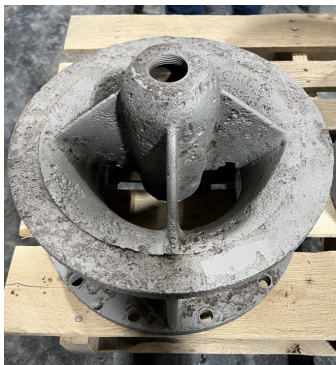
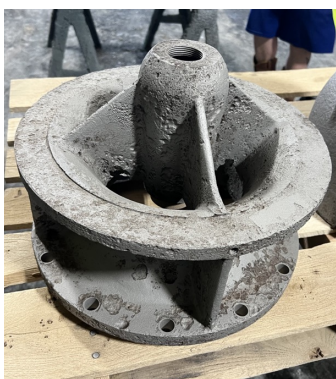
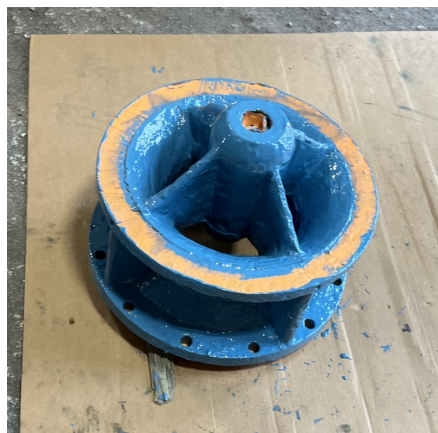
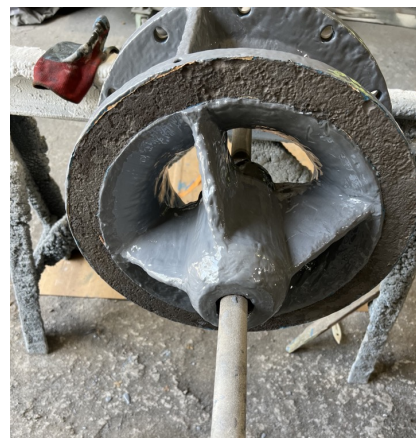
The veins on this vertical inline pump for a cooling tower at a refinery had severe abrasion wear because of the 30 years of service it provided. The client wanted to see how the Resimac products could compete against the competition, and it came out with an exceptional review..

As you can see, the vein was 50% gone so the vein needed to be rebuilt with [Resimac 201 Ceramic Repair Paste](#) and [Resimac 808 Reinforcement Mesh Tape](#).

After we rebuilt that piece, there were 6 other pieces of the pump that we coated with two coats of [Resimetal 202 Ceramic Repair Fluid](#) on the inside. This created a smoother surface for pump efficiency and provided abrasion resistance.

All the external pieces of the pump were coated with [Resichem 501 CRSG](#) in two colors.

With the 2-color system, when the pump goes back in service the client will be able to tell if the pump needs recoating because the gray layer will wear out showing the blue layer. If the client chooses this method of prevention, they will not need to rebuild the structure and will only need to put the top color coat on in the future.
