Containment Area Repair

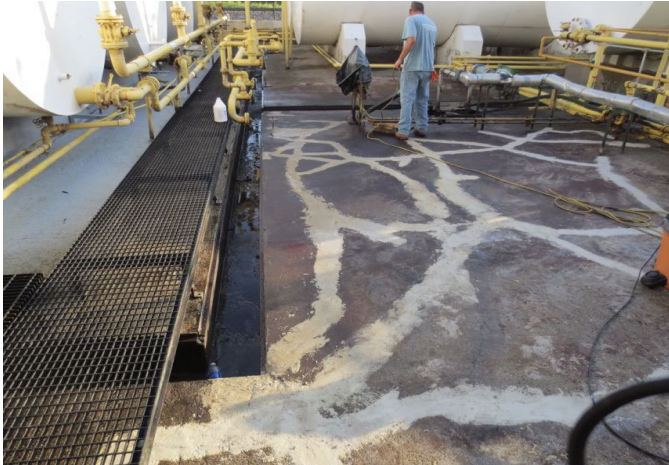
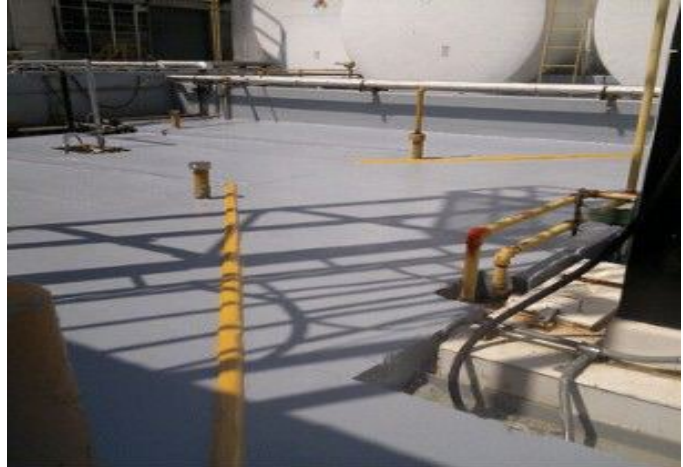
The EPA was about to fine this automotive engine manufacturer for the condition of their secondary containment. This containment area was in need of repairs and a new chemical resistant lining.

As you can see, we repaired many cracks but also added burms to make the flow go in the proper direction. The product used here was [Resichem 576 Quartz Screed](#).

After repairing the concrete and adding the burms, [Resichem 571 Concrete Repair LW](#) Unconventional Solutions sealed the area with and [Resichem 503 SPEP](#) followed by [Resichem 501](#).

USI then coated the yellow striping with [USI Fast Striping Line Marker](#).
