## Cooler Tower Basin Repair

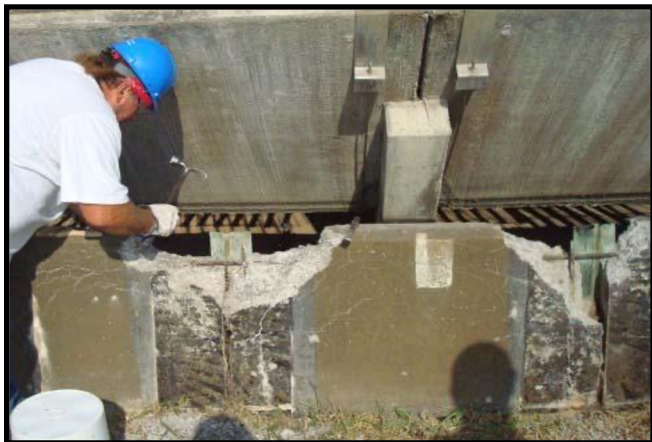
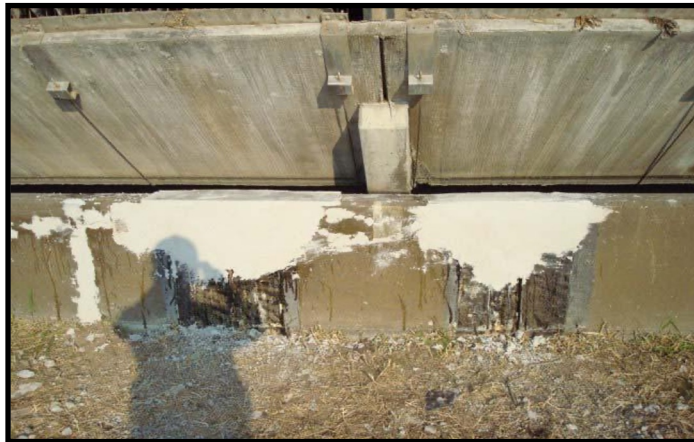
The client was having problems with this cooling tower basin at a nuclear power plant because it was in desperate need of repair.

The basin was deteriorating, the concrete wall was badly cracked and wearing away, and corrosion was affecting the exposed metal

The exposed rebar was coated with [RESICHEM 506 Aluprime](#).

The damaged concrete was prepared and repaired with [RESICHEM 571 Light Weight Concrete Repair](#). This lightweight repair mortar is excellent for vertical or overhead surfaces. It provides a strong, durable repair to any concrete or mineral, and is 100% solid and VOC free. This lightweight mortar gives the customer 6000 psi of compression strength.

This 2-year repair ended up lasting for over 6 years without the client needing to replace the entire cooling tower basin.
