Digester Pipe Repair

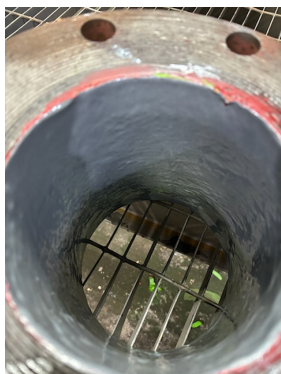
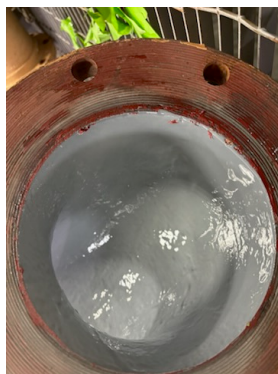
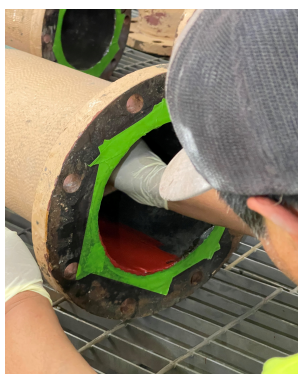
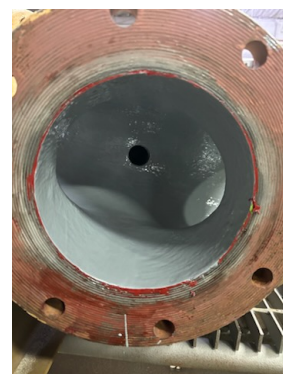
A Wastewater Treatment Facility was experiencing significant issues with digester pipes clogging.

Over time, an 8-inch diameter pipe had become choked down to a 1-inch diameter due to buildup on the pipe walls. This buildup caused back pressure issues and placed a strain on the pumps.

Additionally, the customer was frustrated with the amount of time and labor required to clean the pipes every few months. The pipes were made of ductile iron and lined with concrete.

USI Groups devised a plan to address the issue using **Resimetal 203 Super Flow** with a primer to coat the interior of the pipes.

Resimetal 203 was chosen for its ability to create a surface 10 times smoother than bare steel, which improves fluid flow dynamics. Unlike the original concrete-lined pipes, **Resimetal 203** eliminates edges and ridges, reducing the chance for future buildup.

The pipes were dismantled and taken to a facility where they were sandblasted to a profile of 2.5-4.5 mils and cleaned using **USI Universal Cleaner**. Once dry, a layer of **Resimchem 503 SPEP primer** was applied to the interior of the pipes. As soon as the primer became tacky, one coat of **Resimetal 203** (red) was applied. After approximately two hours, when the first coat became tacky, a second coat of **Resimetal 203** (grey) was applied. The pipes were allowed to cure for two full days before being returned to the customer and reinstalled.
