## Church Steeple Roof Line Repair

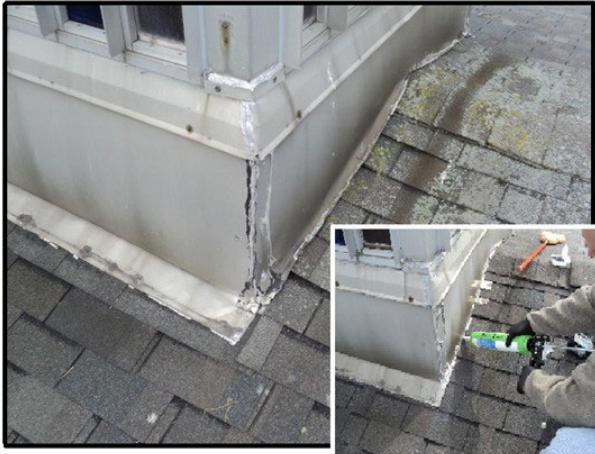
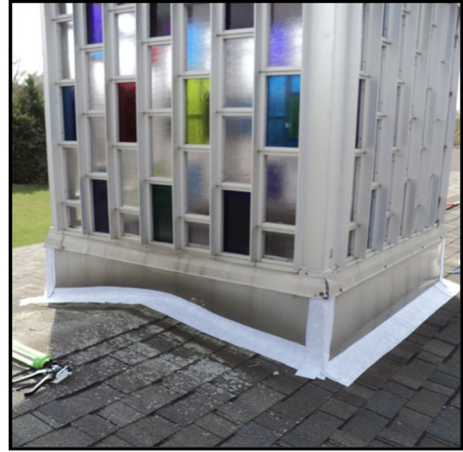
This church was having issues with moisture in the steeple at the roof line.

This moisture was penetrating the roof and going into the ceiling, causing issues with the lights.

[Viscotag Sealant](#) was used to repair the steeple roof line and prevent moisture from causing further damage.

The viscoelastic sealant was used to seal the area where the base of the steeple meets the roof. Then, the sealant was covered with [Viscotag EZ Wrap](#) for added protection.
