Steel Mill Elevator Shaft

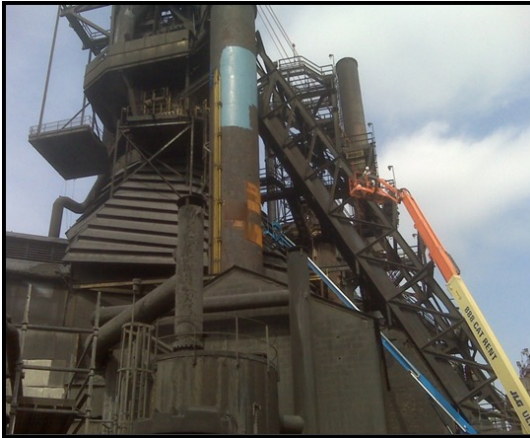
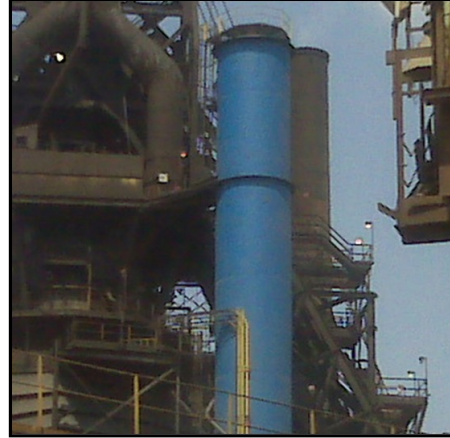
A steel mill in Michigan was experiencing heavy corrosion issues in the elevator shaft of one of their blast furnaces.

The elevator shaft was coated with [RESICHEM 555 Resinox](#). [RESICHEM 555 Resinox](#) is a single component, water-based, anti-corrosive acrylic coating which offers superior elastomeric properties. It is simple, easy-to-use, and requires minimal time between applications.

The elevator shaft was wire brush prepped which provides a surface profile for excellent adhesion. One coat of [RESICHEM 555 Resinox](#) was applied, by brush, to a DFT of 14 mils.

The elevator shaft has been given a face lift with superior corrosion protection. The steel mill chose [RESICHEM 555 Resinox](#) for its ease of use and its superior performance as both a maintenance coating, and a labor cost savings.
