Diesel Tank Exterior Refurbishment

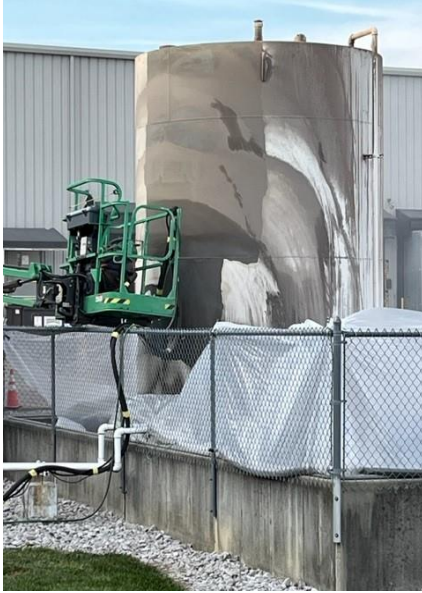
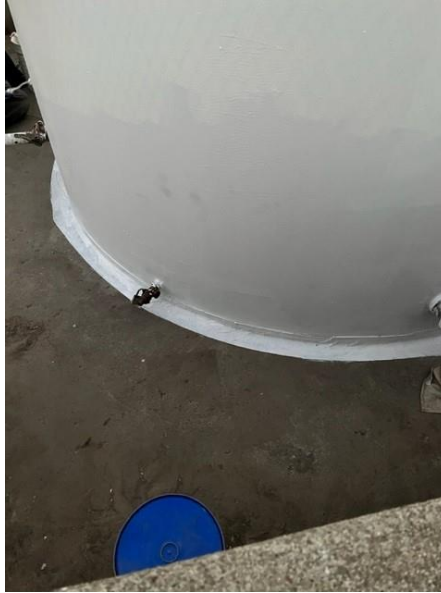
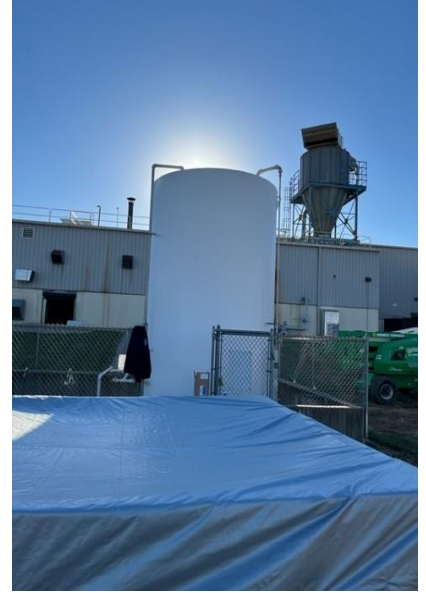
The current coating on the steel tank was beginning to fade due to exposure to the elements, and the customer wanted to enhance and improve the facility's appearance.

Unconventional Solutions Inc. (USI) took a systematic approach to refurbish the tank:

- Surface Preparation:** USI began by abrasive blasting the entire surface of the tank.
- Primary Sealant Application:** Viscotaq ViscoSealant was applied to the tank chime area, where the steel tank met the concrete base.
- Protective Wrapping:** The application of Viscotaq ViscoSealant was followed by the installation of Viscotaq EZ Wrap over the entire tank chime area. This wrap formed a robust protective seal around the tank chime, safeguarding the area against water ingress and corrosion.
- Coating:** To complete the refurbishment, USI applied two coats of white Resichem 555 to the entire surface of the tank. This product was specifically chosen for its high UV resistance, protecting the tank from the damaging effects of sunlight, and its superior corrosion resistance properties.
