Break Room Floor

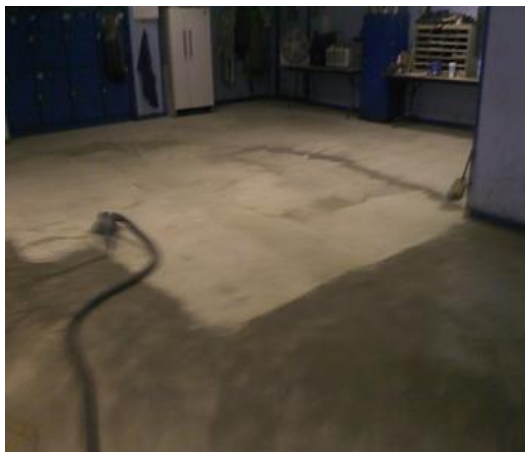
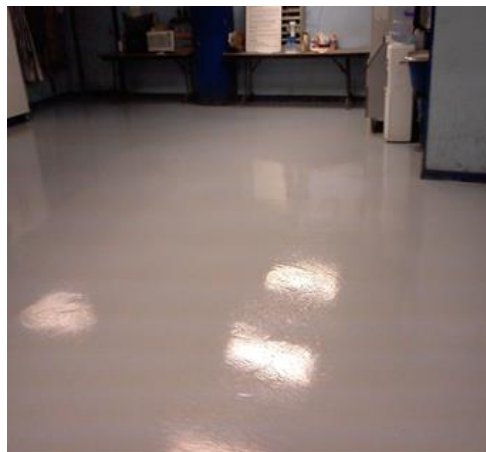
The break room floor at this steel company was damaged from everyday wear and tear. The concrete floor in this 800 sq. ft room was beginning to crack, creating a hazardous environment for the employees and the company.

The break room floor surface was cleaned. Then the surface was prepped with a diamond wheel grinder to give the floor the proper surface profile.

After surface prep was completed, [USI Flexible Primer](#). [USI Flexible Primer](#) is a solvent free floor primer that offers excellent adhesion to concrete surfaces. The floor was then coated with [USI High Build](#), a high build, ceramic enhanced, solvent free floor coating. [USI High Build](#) provides a high-performance finish with good abrasion and chemical
