## Concrete Joint Repair

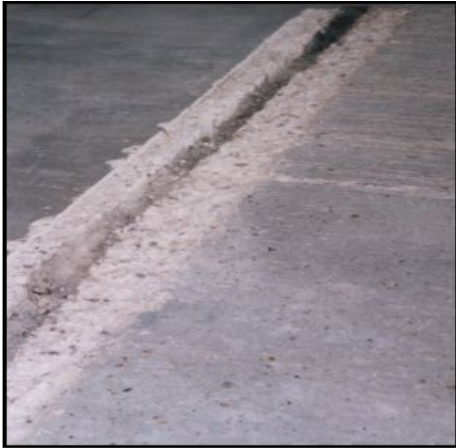
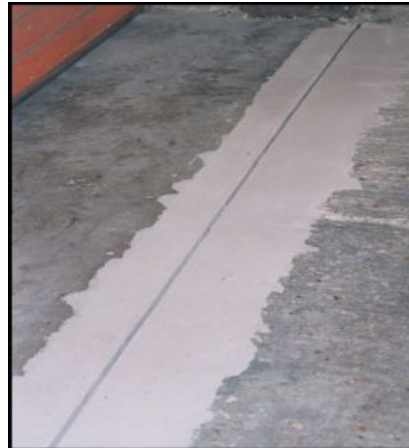
The client was having problems with a very wide movement joint (2.4 – 3.0 inches) between a building and the external concrete.

This was causing difficulties for fork-lift truck drivers who were having back problems due to the jolting when driving over the uneven surface. They were losing loads off the forklifts, resulting in delays and damage to goods.

The solution to the problem was to reduce the joint to 0.4 inches, and to provide a smooth surface across the joint.

Two 0.4 inch deep slots were cut in the concrete on either side of the wide, uneven surface joint.

The concrete was chiseled out, forming a recess 0.4 inches deep. The area was cleaned and primed. A 0.4 inch timber batten was used to form the joint, and the void was filled with RESICHEM 576 Quartz Screed.

The joint was then filled in with RESIFLEX 406 GP 85 Putty.
