Hospital Pad Repair

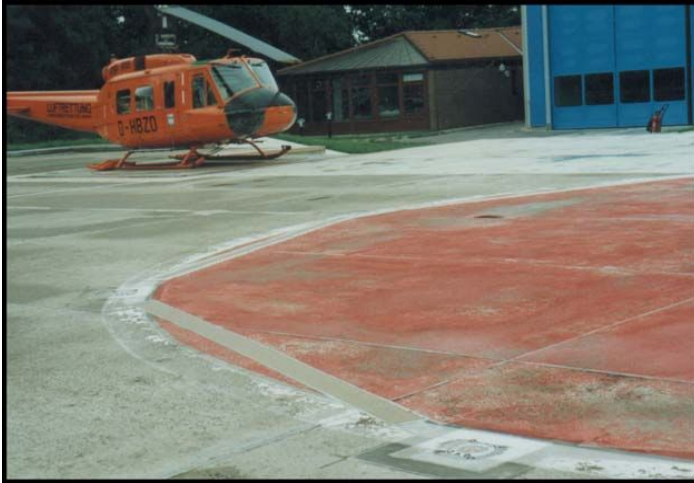
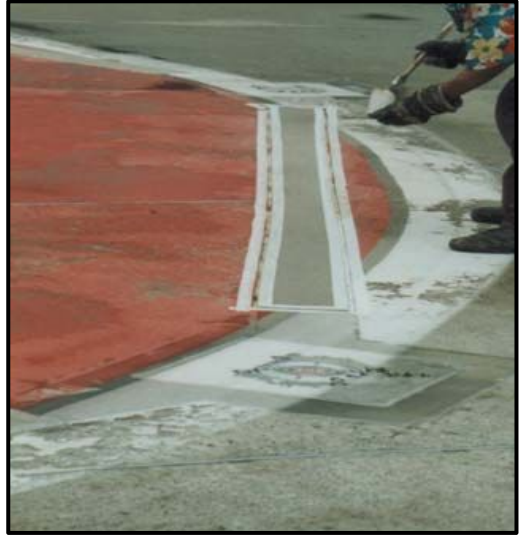
The lights and cables around the landing area needed replacing. The pad could only be out of service for a short period of time thus, a repair system that would cause minimum disruption was necessary.

All damaged and loose concrete was removed. Channels approximately 8 inches wide and 4 inches deep were formed in the concrete.

The cables were replaced, and the damaged areas were rebuilt with RESICHEM 570 Concrete Patch Repair XF

This repair caused minimum disruption, and after four hours the pad was back in service.
