## Auto Plant Striping Pit Repair

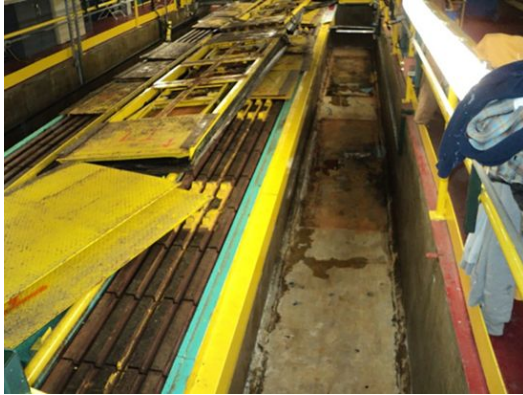
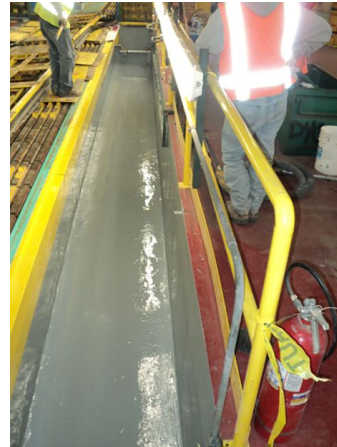
The striping pit at this Michigan auto plant, where the cars get their racing stripes, was accumulating damage from condensation and moisture penetration.

The plant was built on a wetland, which contributed to persistent groundwater penetration. Numerous treatments were applied over the years, but nothing was keeping the water out and protecting the concrete.

USI recommended RESICHEM 573 Fastfill Screed Concrete Seal, a membrane that prevented moisture intrusion into the pit.

Included in this solution were USI Moisture Vapor Barrier and USI High Build Epoxy Floor Coating.

RESICHEM 573 Fastfill Screed Concrete Seal, can hold up to 140 PSI of hydrostatic pressure. This is the ideal solution for basements, floors, walls, and ceilings that are fighting the battle with moisture infiltration.
