## Automotive Tunnel Water Leak Concrete Repair

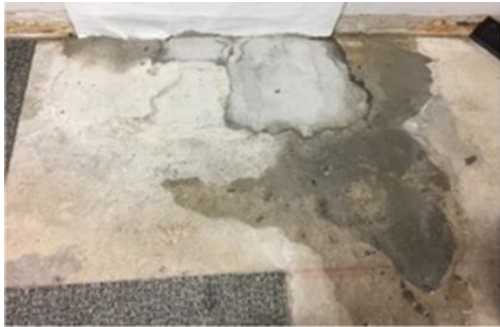
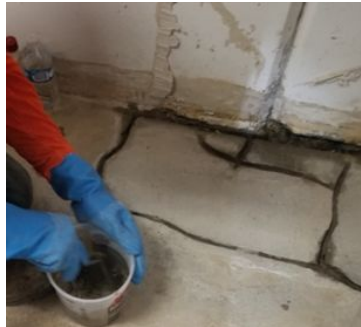
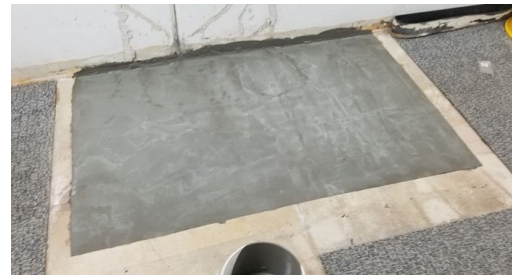
This automotive company had a tunnel that was leaking for over 10 years!

The USI team started with peeling the base board off the wall and discovered that the leak was even coming through the wall, not just the floor.

After scraping out 4 inches of wet concrete from within the wall, and almost 10 inches off of the floor, the USI team used RESICHEM 574 Fastfill Plug to stop the leaks. This is a single component fast-curing engineering-grade, polymer-modified, reactive cementitious putty for arresting water seepage. The product stops infiltration under pressure through cracks, joints and voids in Concrete.

After the USI team stopped the active leaks, we topped off the area with RESICHEM 573 Fastfill Screed – Concrete Seal. This is a single component, engineering-grade, polymer-modified, reactive cementitious coating with high adhesive properties. It is used in permanent immersion or negative pressure waterproofing. It resists hydrostatic pressure up to 145 PSI.
