Secondary Containment Outside Wall

PROBLEM

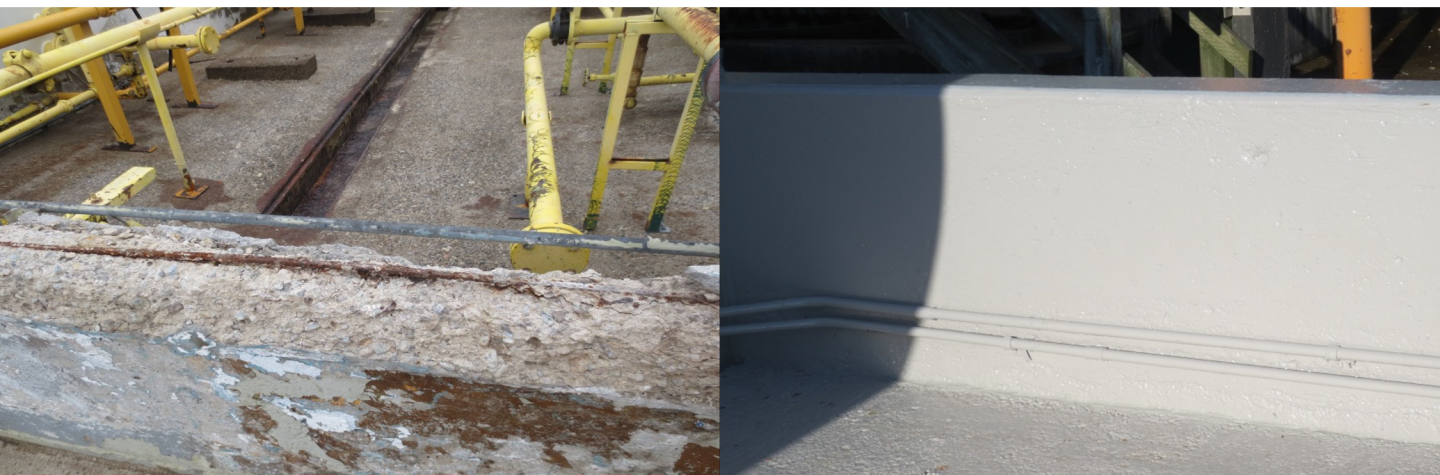
The EPA was about to fine this automotive engine manufacturer for the condition of their secondary containment. One of the issues was that the wall rebar was exposed and it was deeply pitted and falling apart.

If one of the tanks in the containment leaks, the secondary containment would not be able to contain the contents.

As you can see, Unconventional Solutions rebuilt the structure of the walls using [Resichem 571 Concrete Repair LW](#).

After the structure was repaired, we then coated the wall with [Resichem 503 SPEP Primer](#).

We followed the primer with [Resichem 511 UCEN](#) to provide it with chemical protection from future erosion and chemical attack.
