Bag House Protection

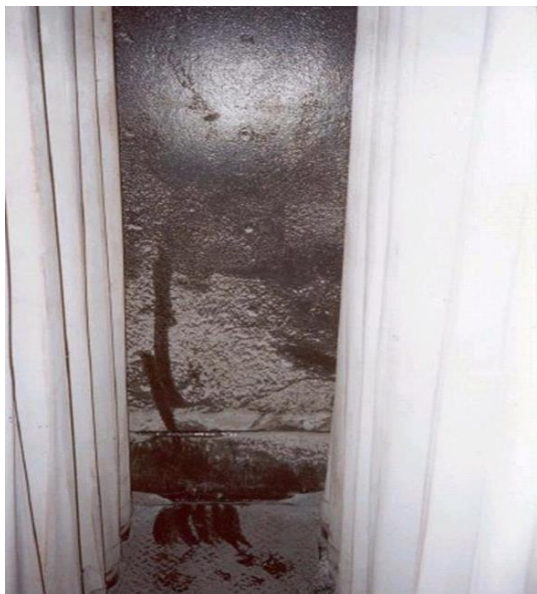
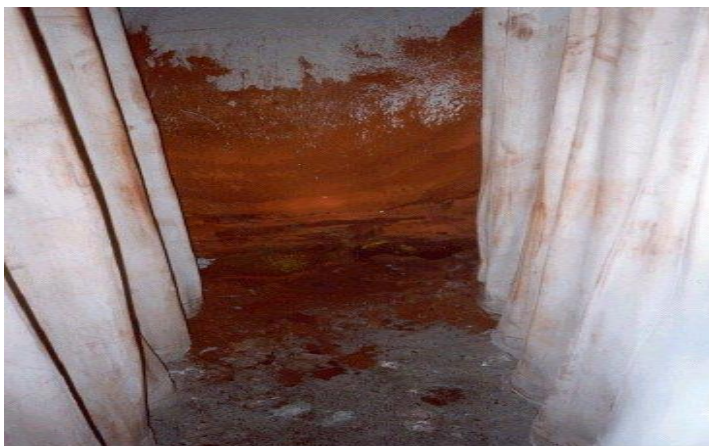
This Midwest Coke & Battery Plant was having problems with erosion and corrosion in their bag houses, causing small holes that constantly needed welding.

USI recommended the entire structure be water blasted to get rid of any salts or excessive corrosion. The small holes were repaired with [RESIMETAL 106XF](#), our 100% solid metal filled polymer repair system.

The entire structure was then coated with two 20 mil coats of **Resichem 501**. **Resichem 501** is a 100% solid, surface tolerant, corrosion protection system. It was selected due to the inability to sandblast the surface and the lower operating temperature.
