Emergency Pipe Leak Repair

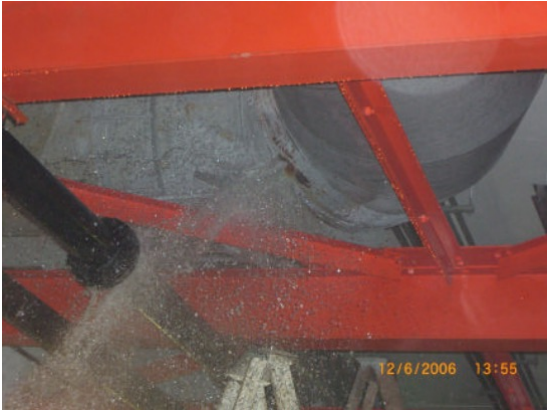
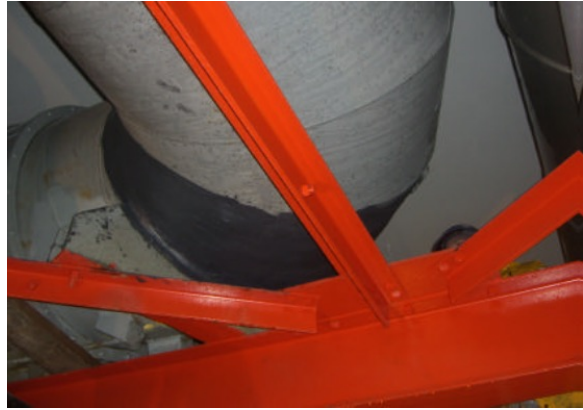
This 48in. suction piping for the return sludge pumps at a wastewater treatment plant had sprung this large leak and several smaller leaks.

Once the fluid source was shut off for pressure, the pipe surface was manually cleaned to an SSPC-SP10 finish. A form was manufactured to cover the leak area, and [RESIMETAL 106 XF Metal Repair](#) was used to fix it in place.

A reinforcing strap was used for added security, and 125 mils of [RESIMETAL 101 Metal Repair Paste](#) was applied. Reinforcing mesh was embedded into the product followed by 125 mils of [RESIMETAL 101 Metal Repair Paste](#)

A 30-mil topcoat of [RESIMETAL 202 Ceramic Repair Fluid](#) was applied to protect the pipe against future impact and chemical damage.

This repair lasted 3.5 years. It never failed but the client received federal grant money to replace the pipe.
