Steel Mill Treated Water Pipeline Leak Repair

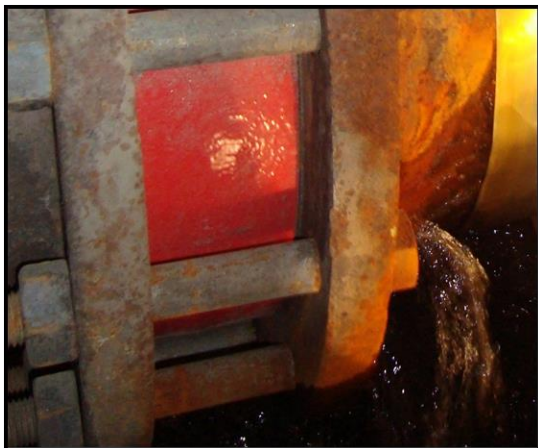
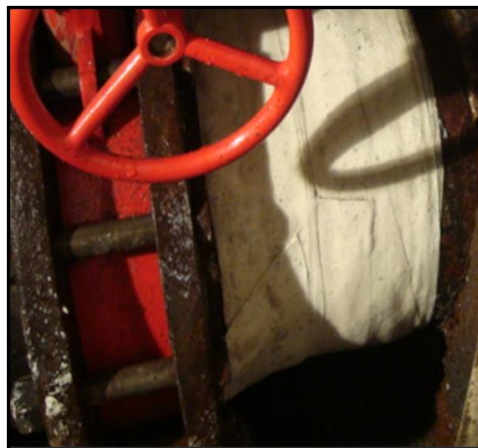
In 2006, a steel mill was losing 50 to 70 gallons/minute on a 10 inch chemically treated water pipeline. This leak was costing the plant almost \$4,000 a day in chemical treatment costs.

They attempted to use a mechanical clamp, but because they were not able to get a tight seal and the repair clamp didn't work, the pipeline continued to lose water at very high rate. The pipe went from 10" to 8".

Unconventional Solutions was able to accomplish this by using [Resimetal 103 Metal Repair Stick](#) in conjunction with [RESIMETAL 108 Pipe Repair Tape](#) to seal the leak in the pipe and bring the water loss to a stop.

As of 2018 the repair was still in service giving the client 12 years of service. It might still be in service today but Warren Miller has since retired.
