Crude Oil Pit Rebuild and Protection

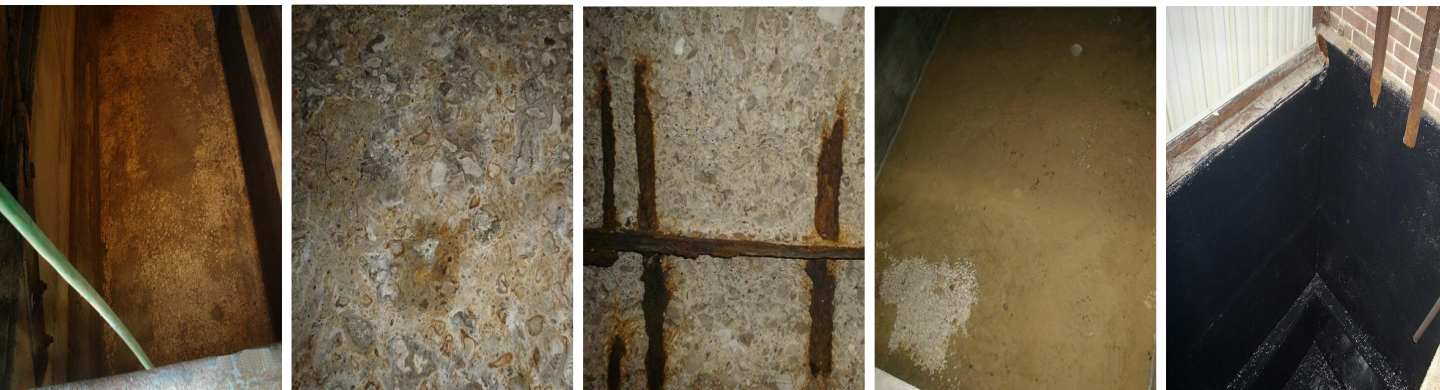
This old crude oil pit was severely decayed.

To accommodate the customer's request, Unconventional Solutions suggested the use of fine sand and [RESICHEM 503 SPEP](#) to get a bulk fill.

[RESICHEM 501 CRSG](#) was used a second time to coat the existing concrete before using two coats of [RESICHEM 501 CRSG](#).

Epoxy coating was used to protect the pit from the crude oil along with anything else which may come in contact with the pit.
