Petrochemical Pipeline Refurbishment

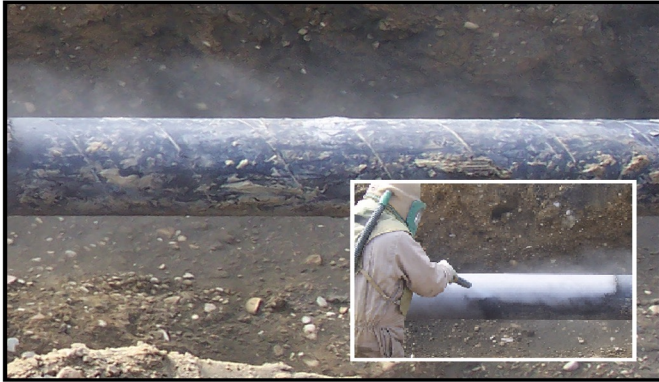
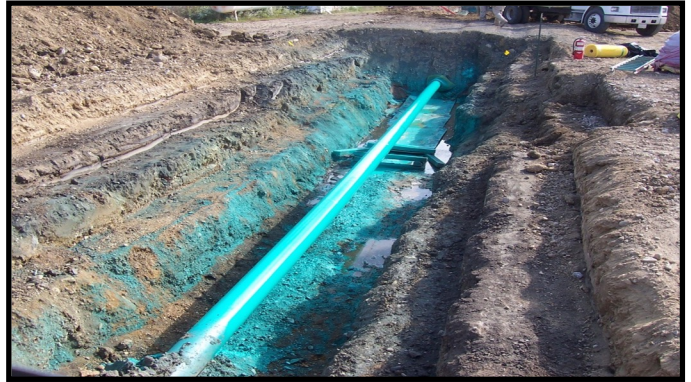
The pipeline had severe corrosion issues exposing risk to the company and the public. As part of the ongoing integrity management program to assure compliance with safety regulations, they were looking for a long-term solution to their corrosion problem.

The petrochemical pipeline was sandblasted to provide a surface profile for proper adhesion.

[3M Scotchkote 323+](#), a two-part liquid epoxy, high performance, high build coating was chosen and then spray applied at twenty-five millimeters thick in one application. This solution provided the pipeline with corrosion protection for years to come.
