Beverage Power Plant Floor Repair

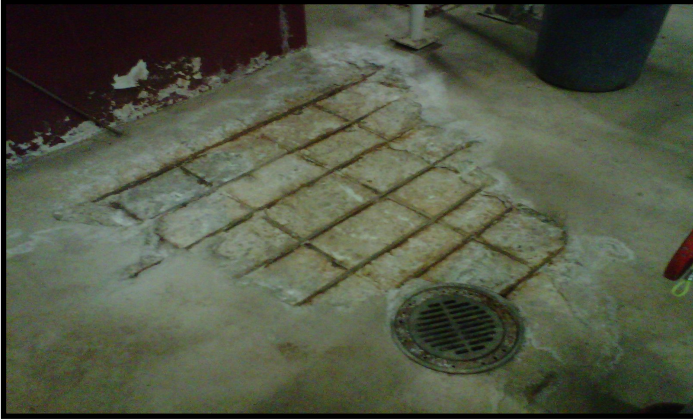
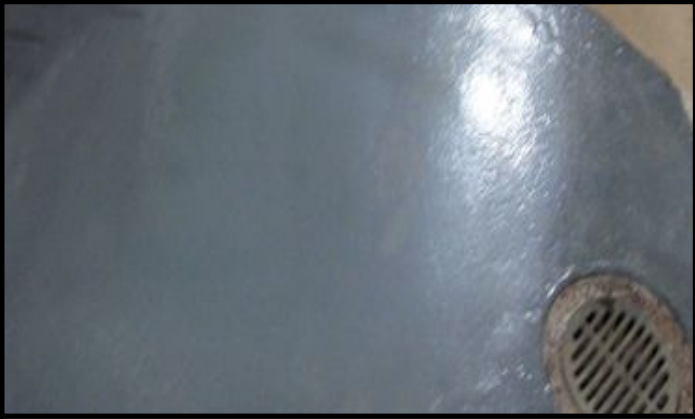
The floor in the power plant of a major beverage manufacturer was badly damaged from constant chemical attack.

The average depth of the damaged concrete floor was between one to two inches.

USI repaired the concrete with RESICHEM 570 Concrete Patch Repair XF, a high-performance repair compound. This concrete repair patch rebuilds and protects concrete while offering outstanding adhesion.

The repaired concrete was coated with RESICHEM 503 SPEP, a solvent free primer, and topped with RESICHEM 511 UCEN. This coating is a two-component coating that provides excellent and long-lasting protection for concrete surfaces subjected to aggressive acids and chemicals.
