## Sulfuric Acid Containment Area

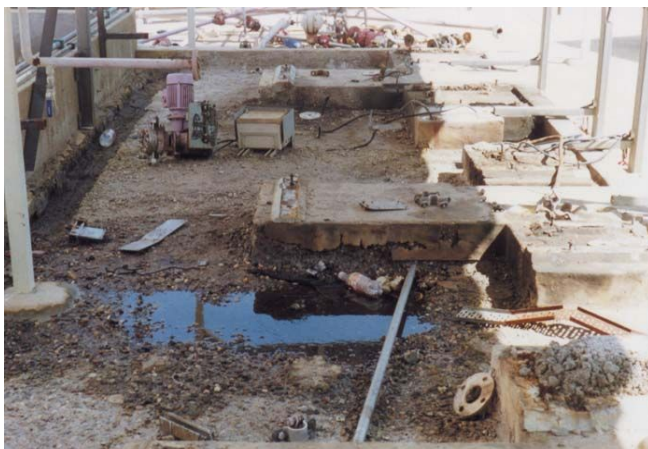
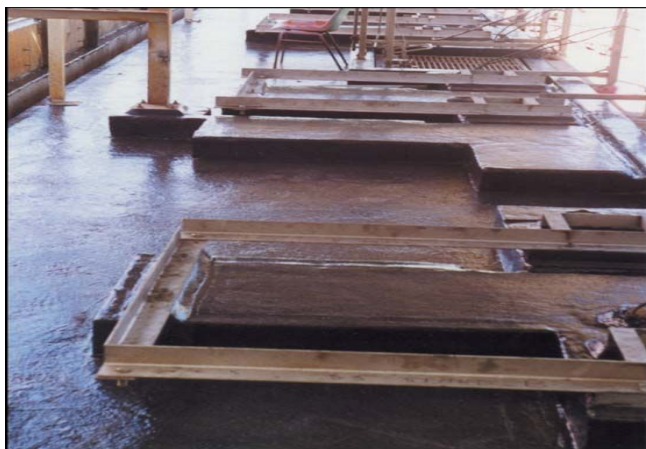
At this power station, there were many sulfuric acid spillages from the pumps and tanks operated by the power company. The sulfuric acid had severely eroded the concrete plinths and the secondary containment areas.

The old concrete was broken up and removed. The secondary containment areas and pads were rebuilt. The area was primed with RESICHEM 503 SPEP followed by two coats of RESICHEM 511 UCEN.

Where a slip resistant surface was required, aggregate was scattered into the second coat of RESICHEM 511 UCEN. A third coat was applied over these areas to seal the grip and provide a chemical resistant surface.
