Wastewater Treatment Plant Tank Base Repair

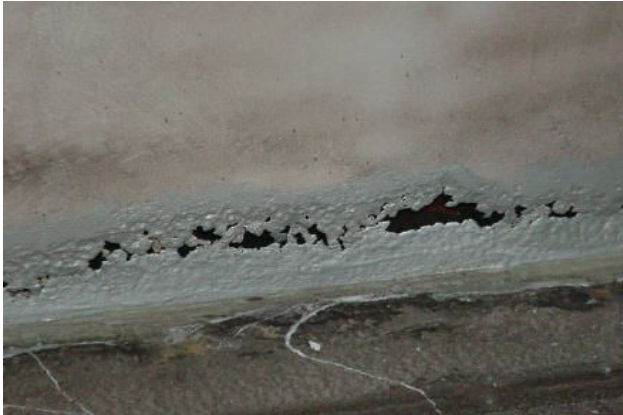
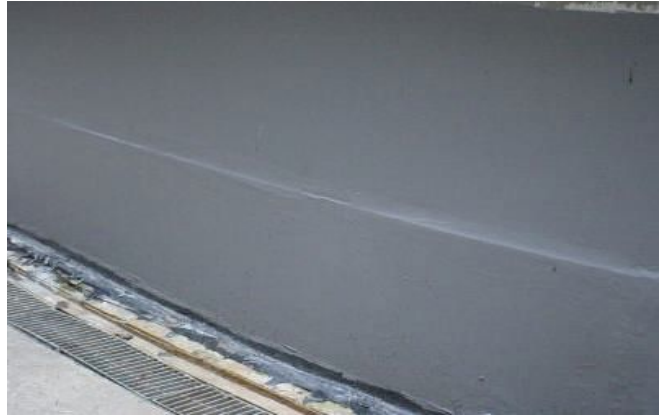
This tank at a wastewater treatment plant was severely corroded and was no longer usable.

The tank was grit blasted and [Resichem 506 AluPrime](#) was applied where there was severe corrosion.

[RESIMETAL 101 Metal Repair Paste](#) was then applied to the severely corroded areas to repair the metal. Steel panels were manufactured; grit blasted, primed, and secured to the tank base with additional [RESIMETAL 101 Metal Repair Paste](#).

After the panels cured in place, two coats of [Resichem 555 Resinox](#) were applied to the tank base exterior and panels to protect it from further damage
