## Chiller Refurbishment

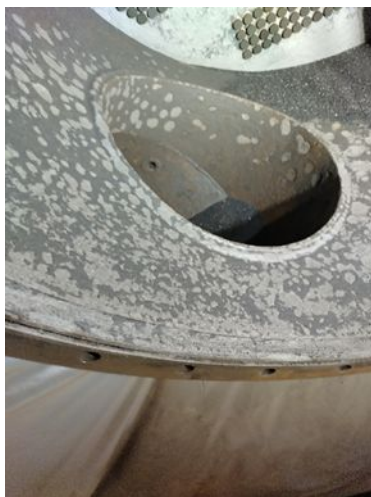
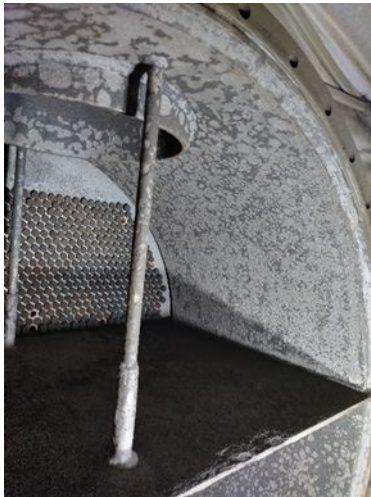
A chiller operator at a large stadium was concerned with corrosion inside one of their chillers. Hearing about our solutions for corrosion protection and prevention, they decided to hire USI to coat the chiller.

To remove the corrosion on the chiller at the time, USI used the NACE #2 standard for surface preparation, abrasively blasting all the corrosion away down to near white metal.

After surface prep, the corroded parts of the chiller were rebuilt using RESIMETAL 201 Ceramic Repair Paste. Then, for the prevention of future corrosion the chiller was painted with two coats of RESIMETAL 202 Ceramic Repair Fluid, one coat red and the other gray. This procedure is standard for the product, as it helps with pinhole and holiday detection.
