Citric Acid Protection

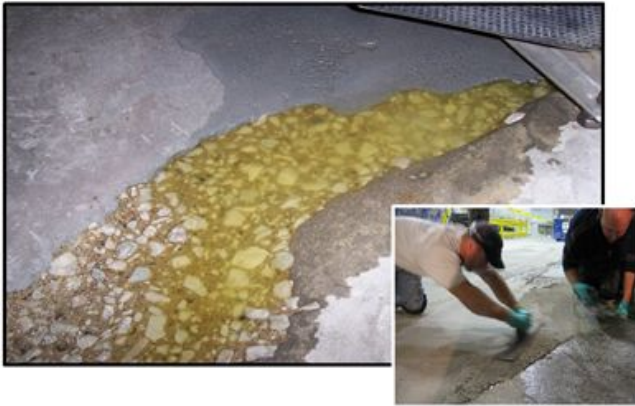
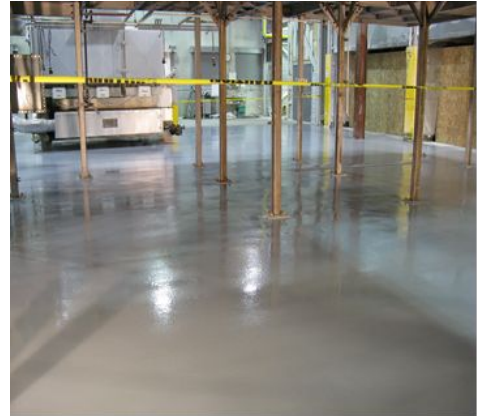
The floor of this candy factory in Indiana was being brutally attacked by citric and lactic acid. This caused the concrete to become cracked and pitted over time.

You can see here what problems the citric acid has caused. They tried concrete patch repairs monthly with no success.

The broken concrete and patch material were removed by scarifying and diamond grinding. Then, the floor was shot blasted.

The damaged areas of the floor were primed with USI Flexible Broadcast Primer and rebuilt with USI Epoxy Mortar Patch Kit.

The entire area was primed with a second coat of USI Flexible Broadcast Primer and coated with our ceramic enhanced USI High Build Epoxy Coat reinforced with aluminum oxide to provide extra protection and slip resistance
