Hospital Chiller Refurbishment

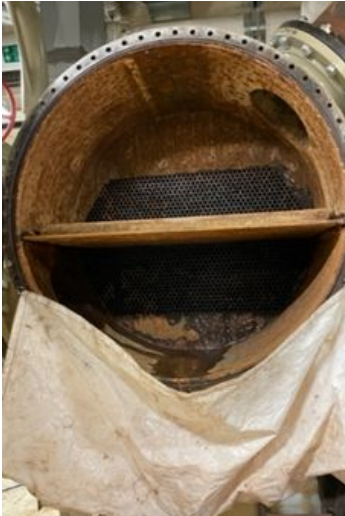
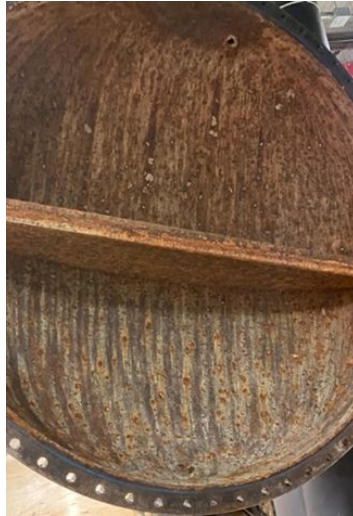
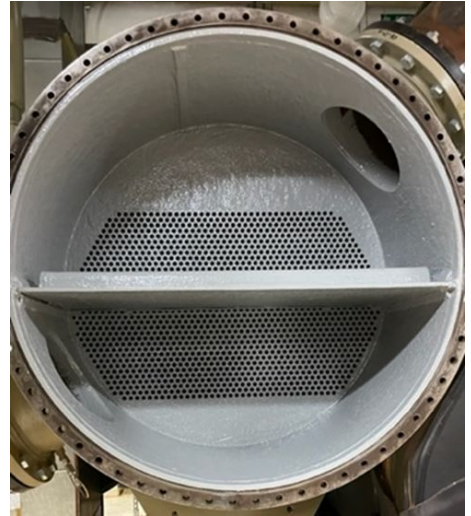
A university's hospital was looking to spend \$450,000 to purchase a new chiller, in which installation would cost over \$1 million. They couldn't get the new chiller because they couldn't even get the old chiller out of the building. Instead, USI was able to refurbish the existing chiller for under \$50,000, saving the university money and the time it would take to remove the old chiller (and part of the building in doing so) and putting in a new one.

First, the chiller's surface was prepared using the NACE #2 standard, blasting the corrosion away to get it back to a near white metal.

The corroded metal of the chiller was then rebuilt with RESIMETAL 201 Ceramic Repair Paste. Once the metal was rebuilt, USI coated the chiller with two layers of RESIMETAL 202 Ceramic Repair Fluid, one coat blue and the other gray. This two-coat system ensures that pinholes and holidays can be detected and fixed, as well as offering better corrosion protection.
