Riser Pipe Refurbishment

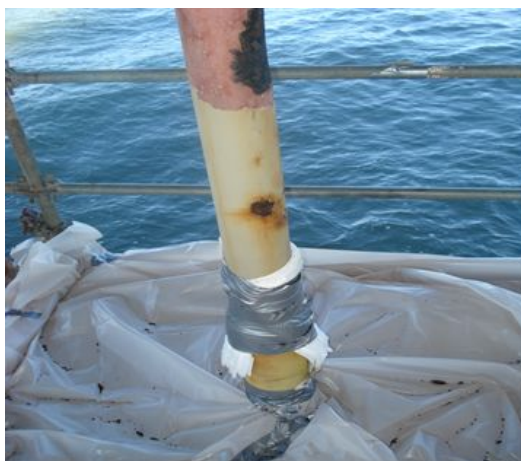
This line had several leaks and was suffering severe wall loss due to corrosion caused from the marine environment.

StopIT Gas Riser Rehabilitation was chosen to repair the production riser. A rapid-setting proprietary polymer system that forms to a solid within minutes. StopIT Gas Riser Rehabilitation is functional in 2-3 hours, and is fully cured within 24 hours. StopIT Gas Riser Rehabilitation encases the riser, seals it from the marine environment, and inhibits corrosion of the pipe surface.

StopIT Gas Riser Rehabilitation repaired the riser, while avoiding costly replacement, hot work, and eliminating the need to shut-in production.
