Power Plant at Big 10 University - 2018

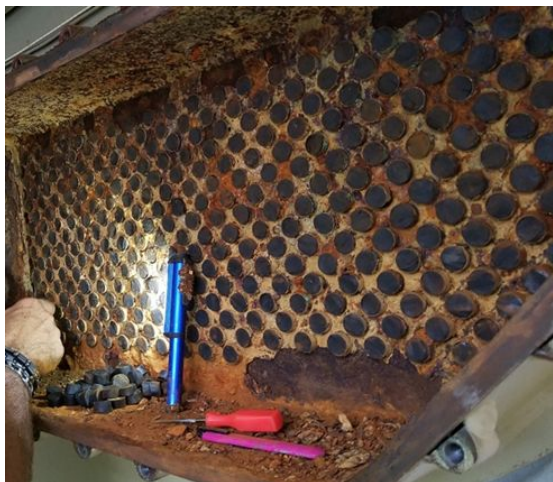
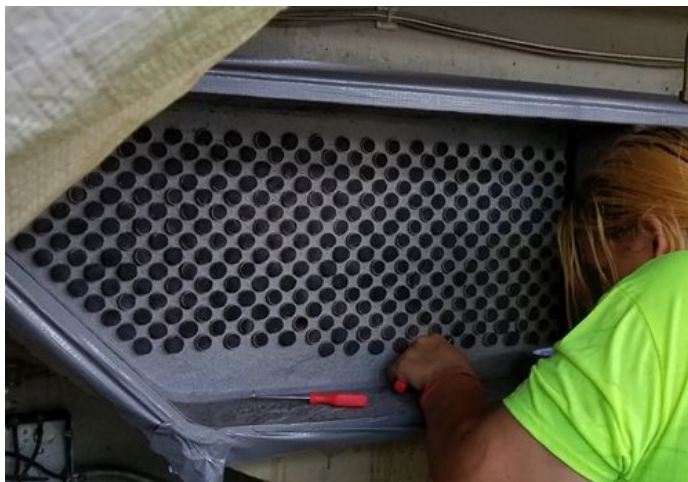
A Power Plant at a Big 10 University was experiencing galvanic corrosion, also known as bimetal corrosion, which was eating away at the metals and causing tubes to plug. This University wanted to lower their energy cost and felt a hydrophobic ceramic enhanced polymer coating would provide a smoother surface and reduce energy bills. Having worked with the USI Team before, they called us in to work on this important project.

The USI Team tented the area to create an exhaust/dust free environment. After blasting the tubes were corked to prevent abrasive blast media from going into the copper tubes.

The USI Team first abrasive blasted to NACE 2 specifications, to a 2 ½ to 4 mil anchor pattern then rebuilt lost metal around the tubes with RESIMETAL 201 Ceramic Repair Paste.

Lastly, two coats of RESIMETAL 203 Superflow Ceramic Repair Fluid were brush applied by the USI Team to give it a smooth, hydrophobic finish to be more efficient and provide an erosion corrosion free environment. The first coat is applied in red, the second in gray, that way as you do your regular maintenance checks on your chiller, if you start to see red you know it's time to re-coat before you allow the galvanic corrosion to happen.
