## Salt Tank Repair

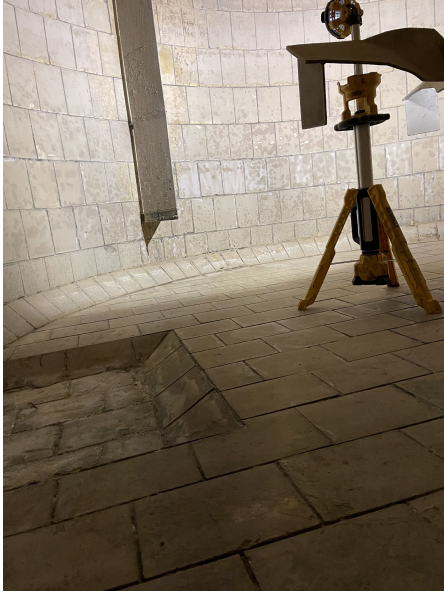
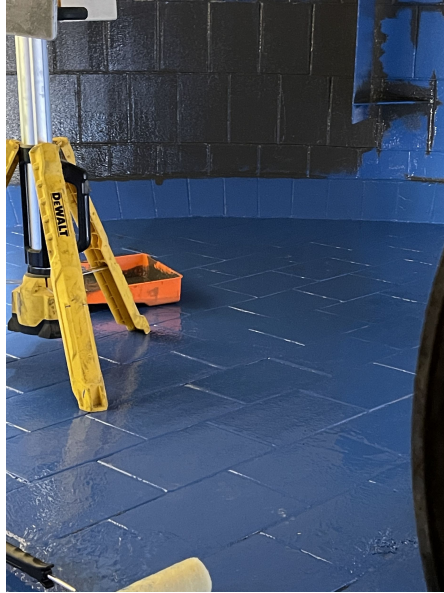
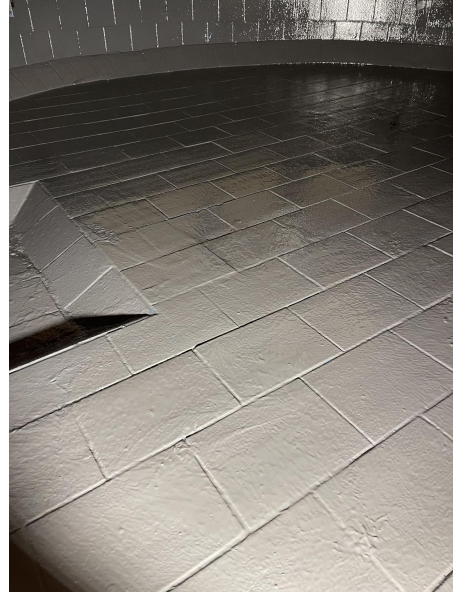
This tank was leaking so the plant called USI to solve their issue.

To prepare the leaking tank for repair, they took the tank down from service and drained it.

We water jetted the concrete to clean and get an ideal profile.

After the tank was dried, we sealed the concrete with Resichem Damp Seal 505.

USI coated the tank with Resichem 501 CRS, a lining, in two different colors to make sure there were no pinholes showing.

A two-color system is recommended for this tank because of the abrasive environment. Once the first coat's color is showing through, the client will schedule the tank to be recoated to continue to protect it from abrasion.
