University Stair Rebuild

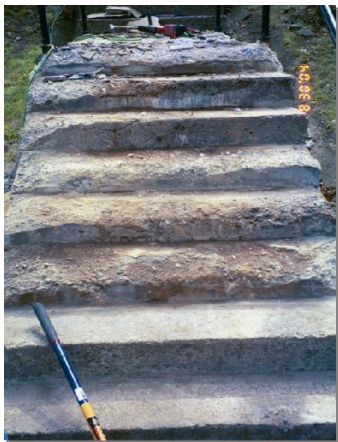
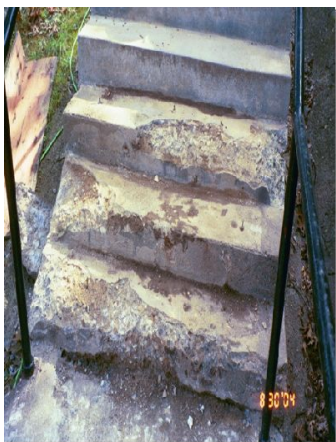
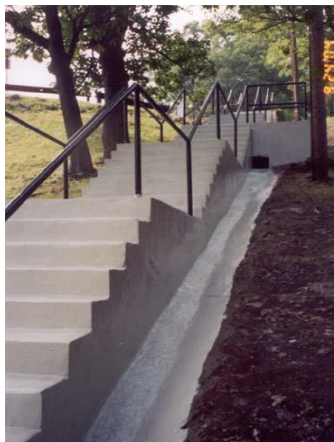
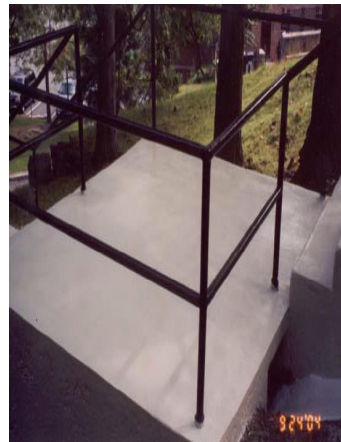
This stairway serves as a main access route for many students. For safety reasons, this stairway needed to be repaired and coated for protection.

The surface was cleaned and abraded before the application of the primer included with 576

The damaged areas on the sides of the stairway were then rebuilt with Resichem 571 Concrete Repair LW

The other damaged areas were repaired with Resichem 576 Quartz Screed which is a three component, solvent-free heavy duty epoxy repair mortar.

The entire surface of the concrete stairway was then primed with Resichem 503 SPEP followed by one coat of USI High Build Epoxy Floor Coating.

USI LD Granular Aggregate was back-rolled into the coating to provide superior slip resistance.
