Burm Buildup for Containment Area

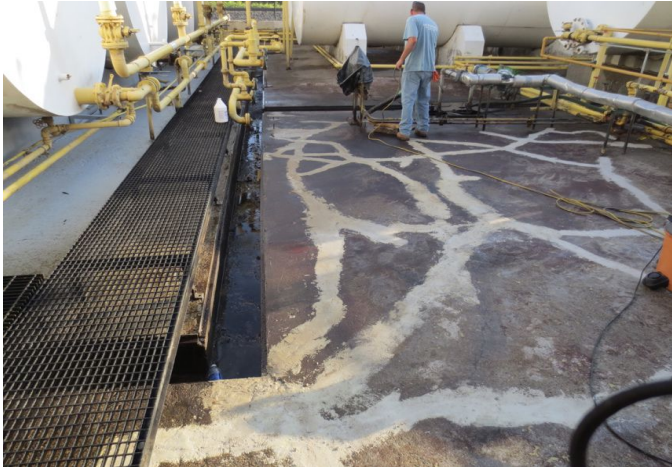
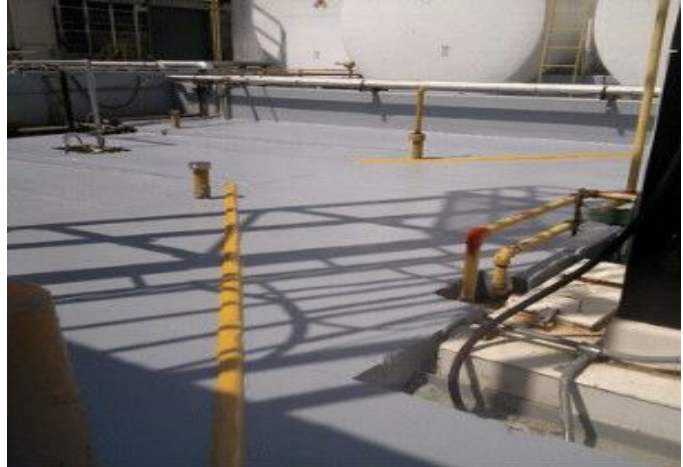
The EPA was about to fine this automotive engine manufacturer for the condition of their secondary containment.

One of the issues was that if this tank leaked, the flow of this containment area was going to be in the wrong direction.

As you can see, we repaired many cracks, but also added burms to make the flow go in the proper direction. The product used here was [Resichem 576 Quartz Screed](#).

After repairing the concrete and adding the burms, Unconventional Solutions sealed the area with [Resichem 503 SPEP](#).

USI then coated the yellow striping with the [USI Fast Cure Line Striping \(yellow\)](#)
