Concrete Repair and Overcoat

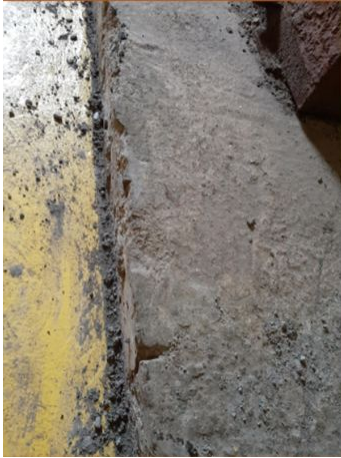
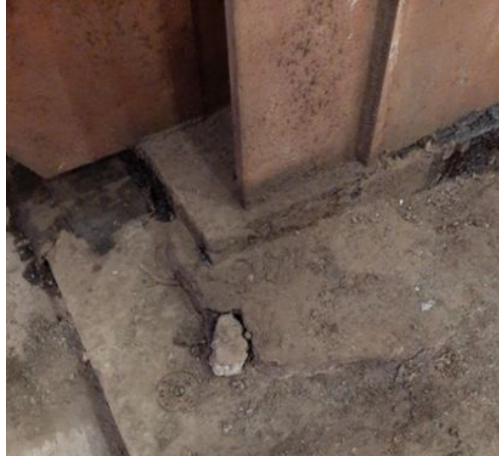
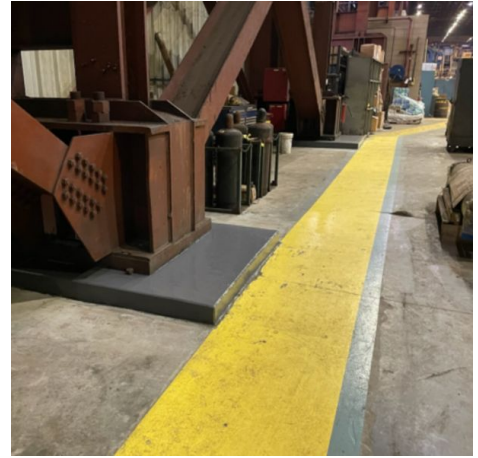
Due to hydrochloric acid in the environment, the concrete piers of this pickling line were severely corroded and had started to crumble. This posed a great threat to the safety of the integrated steel plant, as the piers reinforced the structural steel holding the walls and roof of the building up.

The concrete piers were first surface prepped using the SSPC-3 standard with power tools to remove loose and damaged concrete.

They were then repaired and coated with RESICHEM 503 SPEP and Resichem 501 CRSG at a thickness of 50 mils. While this was a recent repair and protection of USI's, similar solutions have lasted for years.
