## Shaft Repair on Rooftop

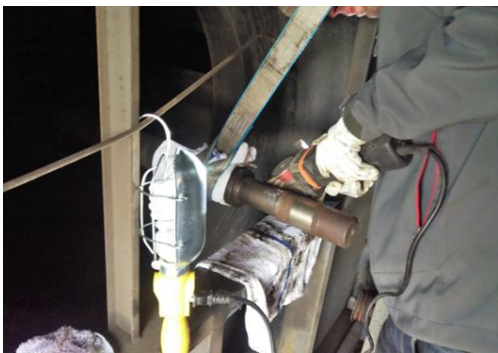
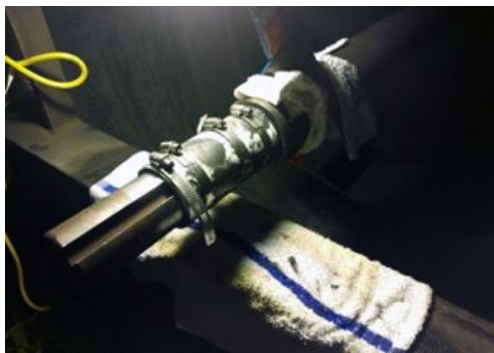
An automotive manufacturing company was hearing heavy vibration of a fan shaft on top of the roof, so they called Unconventional Solutions out for an emergency repair to fix a cracked shaft. The shaft was located in a penthouse HVAC building on the roof of a warehouse used for heating. The shaft was 6ft long, with a wear area 2"- 3" wide, by roughly 1/16"- 1/8" deep, caused from a bad bearing. A new shaft alone costs nearly \$2000 and would take 4 weeks to be delivered. A factor of 4 days of downtime and labor costs of 4 employees working 10+ hour days totaling approximately \$5000 to get the replacement shaft installed ready for service was also an issue.

As a turnkey project USI recommended using RESIMETAL 101 Metal Repair Paste. The shaft was solvent cleaned with USI Universal Cleaner, prepped with the MBX Bristle Blaster to achieve an anchor pattern of 2-3mils and SSPC-SP2 or SP3 standard then followed by another application of USI Universal Cleaner to remove any oil or debris.

RESIMETAL 101 Metal Repair Paste was properly mixed according to its Technical Data Sheet and formed with PVC pipe, lined with USI Release Agent and hose clamps to the wear area of the shaft. Heat was applied for a quicker overall cure time.

The project was completed in 6 hours and allowed to finish curing and was back in service within 48 hours.
