Conveyor Belt Cleat Issues

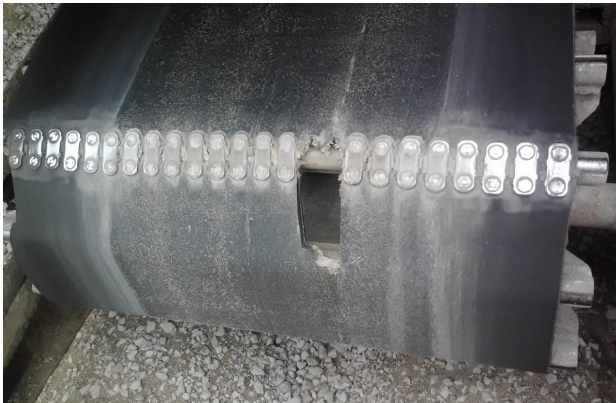
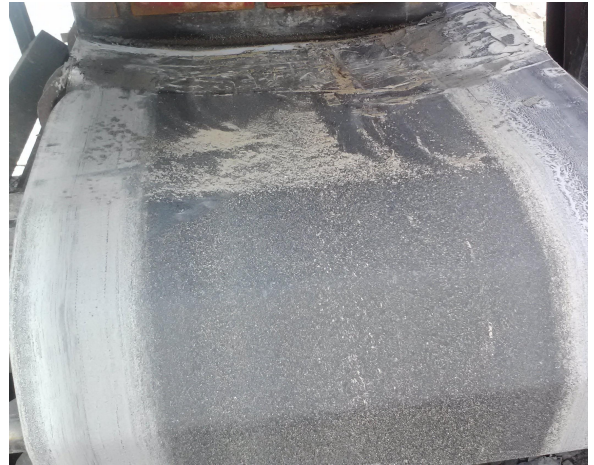
A local concrete plant was continually having problems with their conveyor belts, especially at the cleats. Since they needed to be back in service very quickly, they opted for a system that can be back in service the same day the repair is completed

First, we cut out the damaged cleat section.

The hole was repaired using a combination of RES808 High Strength Reinforcement Mesh Tape and RES401 GP 60 Putty. We used a wide cellophane tape over the cleats to allow them to still move freely over the rollers.

We then coated the entire cleat section with more RES401 GP 60 Putty.
