## Conveyor Belt Repair

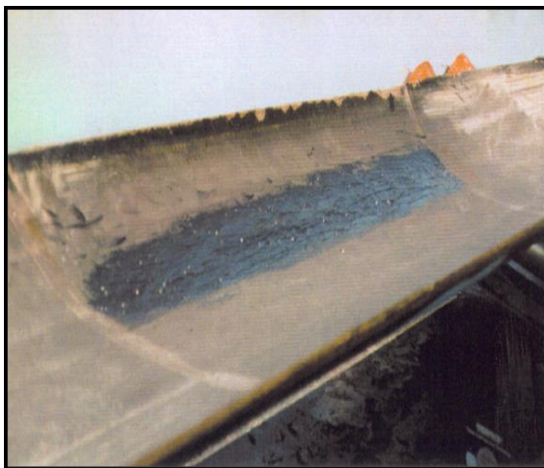
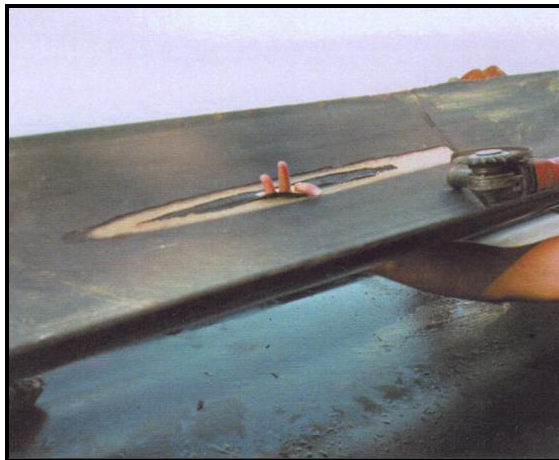
Tears and rips to conveyor belts are common problems in industry. Replacement of a conveyor belt is very expensive and time consuming, which can lead to long delays in production.

This rock quarry was in desperate need of a system that allows the damaged area to be repaired immediately with minimum amount of disruption, and a quick return to service.

Resiflex products are ideal for the repair of worn and damaged conveyor belts. For this conveyor belt, Resiflex 406 was chosen because it needed to be back in use quickly. Resiflex 406 is a fast-curing paste that provides a flexible, effective repair to many rubber surfaces.

First the surface was cleaned and then primed with Resiflex 402. The reinforcement on the belt had worn away, and two layers of Reinforcement Mesh 808 tape were embedded into the Resiflex 406 and completely encapsulated. The damaged area was then totally repaired. The customer was delighted at the speed of the repair and massive savings that it has provided the company.
