## Steel Mill Secondary Containment

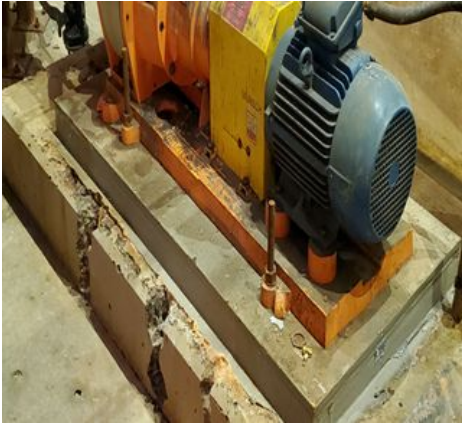
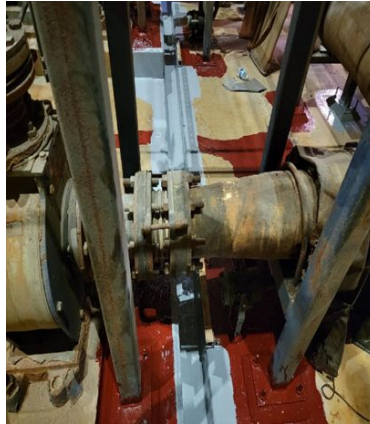
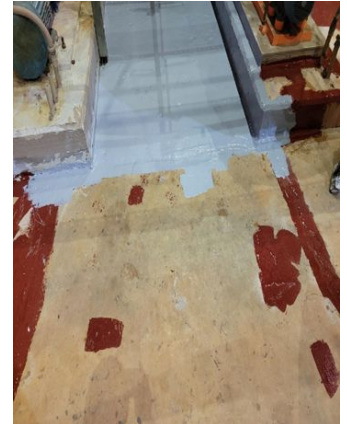
This steel mill had a severely corroded secondary containment area caused by hydrochloric acid at elevated temperatures continuously hitting their trench.

Since the hydrochloric acid was very acidic the first step was to neutralize the concrete to a neutral PH level or even to a caustic environment to a level between 7 and 10 .

After treating the area to create a neutral environment, Duomar RPC Repair Polymer Concrete was used to rebuild the areas that were eroded.

After the areas were rebuilt, one coat of Duomar DF 1303 was applied as the primer followed by two coats of Duomar HPL-4320.

One coat of Duomar HPL-4320 was applied in red and the other was applied in gray. This allows for maintenance crews to visually see when the coating is wearing off and a recoat is needed.
