Steel Mill Secondary Containment

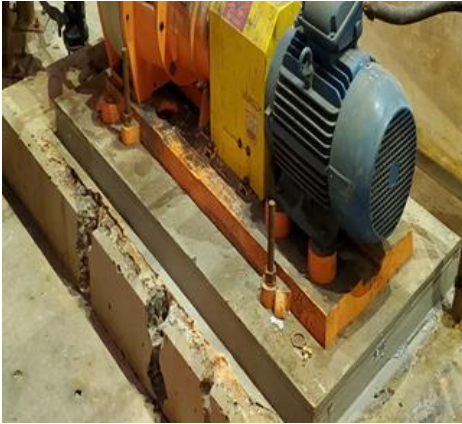
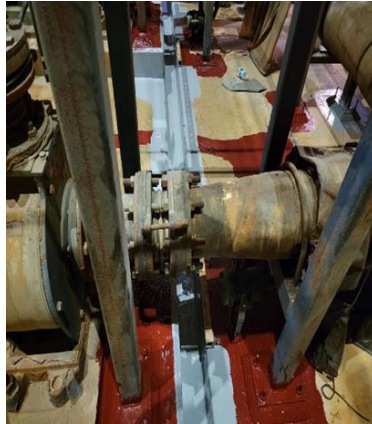
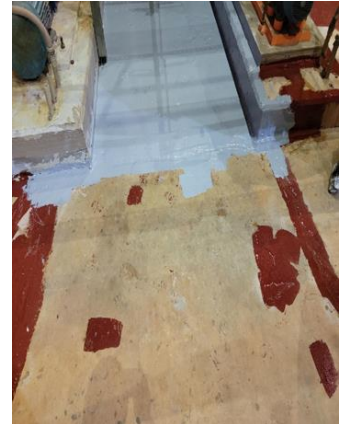
This steel mill had a severely corroded secondary containment area caused by hydrochloric acid continuously hitting their trench.

Since the area was contaminated with hydrochloric acid the first step was to neutralize the concrete to a neutral PH level.

After neutralizing the substrate, [Duromar RPC Repair Polymer Concrete](#) was used to rebuild the areas that were eroded.

After the areas were rebuilt, one coat of [Duromar DF 1303](#) was applied as the primer followed by two coats of [Duromar HPL-4320](#).

One coat of [Duromar HPL-4320](#) was applied in red and the other was applied in gray. This allows for maintenance crews to visually see when the coating is wearing off and a recoat is needed.
