Cooler Tower Basin Repair

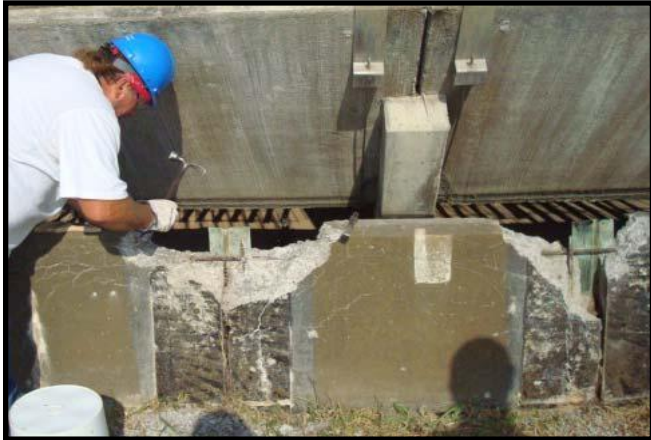
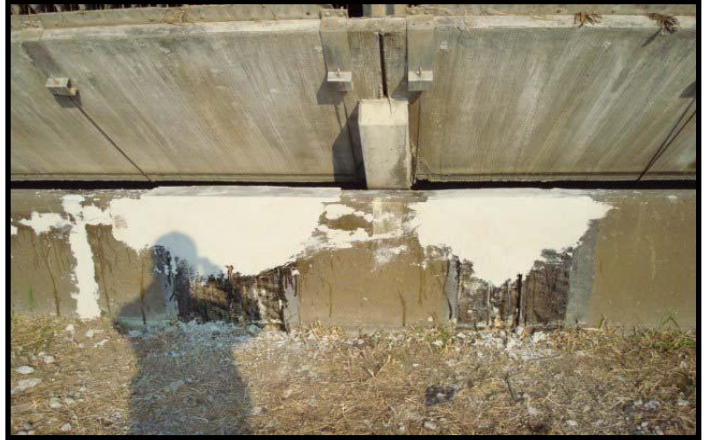
The client was having problems with this cooling tower basin at a nuclear power plant because it was in desperate need of repair.

The basin was deteriorating, the concrete wall was badly cracked and wearing away, and corrosion was affecting the exposed metal

The exposed rebar was coated with [RESICHEM 506 Aluprime](#).

The damaged concrete was prepared and repaired with [RESICHEM 571 Light Weight Concrete Repair](#). This lightweight repair mortar is excellent for vertical or overhead surfaces. It provides a strong, durable repair to any concrete or mineral, and is 100% solid and VOC free. This lightweight mortar gives the customer 6000 psi of compression strength.

This 2-year repair ended up lasting for over 6 years without the client needing to replace the entire cooling tower basin.
