Utility Company's Warehouse Aisle Restoration

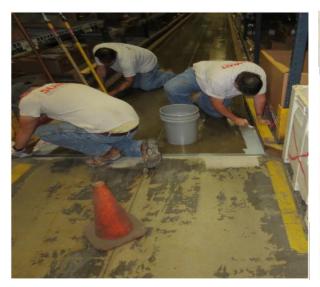
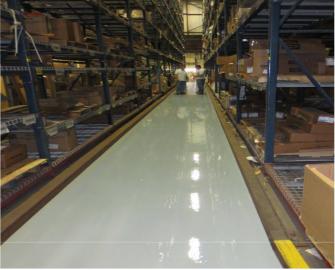
This warehouse floor was reaching the end of its life cycle and the client was looking for a way to refurbish it instead of tearing it up and pouring a new floor. This is the main warehouse that runs 24/7 for the utility company, so they are not able to close it down.

Once the area was fully prepped, we coated the entire area with <u>USI Flexible Broadcast Primer</u> followed by 2 alternating color coats of <u>USI High Build Epoxy Floor Coating.</u> As you can see in the picture above, we were cutting in on the edges with brushes then used squeegees and rollers on the rest of the floor.

To prep the floors, we used vacuum blasting on the large open areas and hand grinding with a vacuum attachment in tight corners. We then thoroughly swept and vacuumed to remove any remaining dirt and debris from the surface.
