NaOCL Rubber Tank Repair

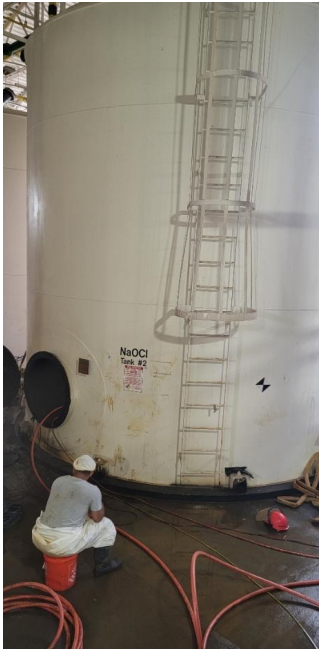
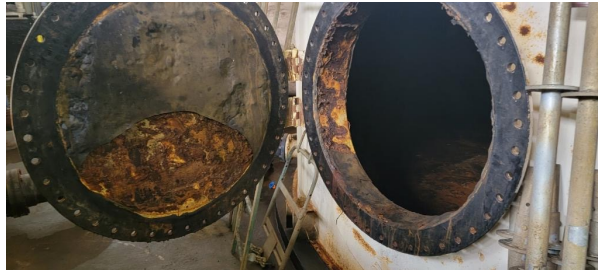
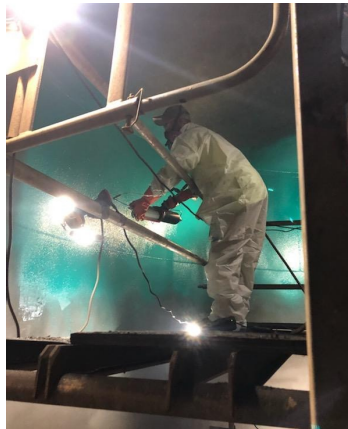
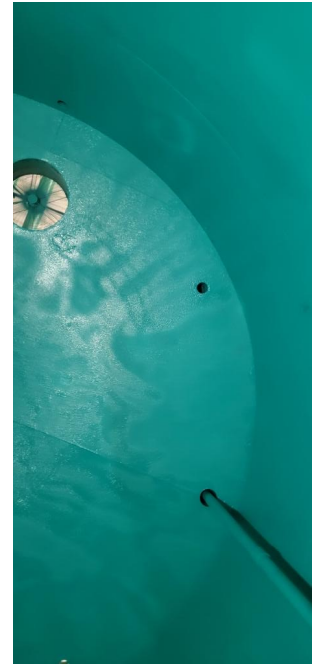
This wastewater treatment facility client called USI because they had a leak in a rubber lining of a steel tank that had been replaced two years ago. He was looking for a system that would last more than two years.

Steel with rubber lining

The owner power washed the tank to remove the caustic elements. To remove the existing rubber lining a 40,000-psi water jet was required.

After removing the rubber lining the tank was abrasive blasted to a SC-SPC -10 or Nace 2. Since the lining had been leaking for a while, the metal had extensive metal loss and the metal was rebuilt with [Resimetal 101 Metal Repair Paste](#)

Then one coat of [3M Scotchkote 323+ 900ml Repair Cartridges](#) was applied at 30 mils wet on wet.

After the application was completed and 72 hours had passed, a holiday spark test was performed.
