Break Room Floor

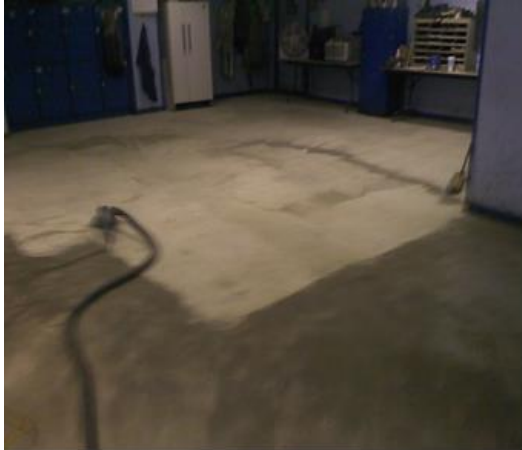
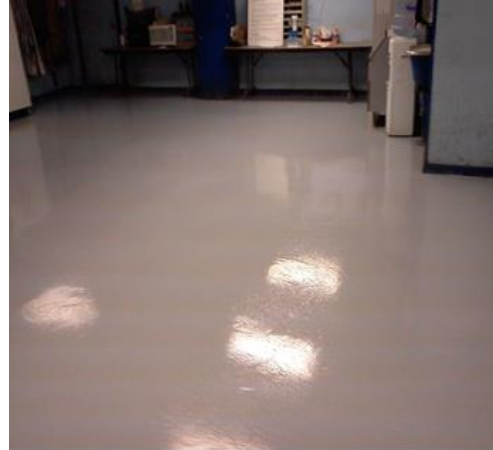
The break room floor at this steel company was damaged from everyday wear and tear. The concrete floor in this 800 sq. ft room was beginning to crack, creating a hazardous environment for the employees and the company.

The break room floor surface was cleaned. Then the surface was prepped with a diamond wheel grinder to give the floor the proper surface profile.

After surface prep was completed, USI Flexible Primer. USI Flexible Primer is a solvent free floor primer that offers excellent adhesion to concrete surfaces. The floor was then coated with USI High Build, a high build, ceramic enhanced, solvent free floor coating. USI High Build provides a high-performance finish with good abrasion and chemical
