In Place HVAC Shaft Repair

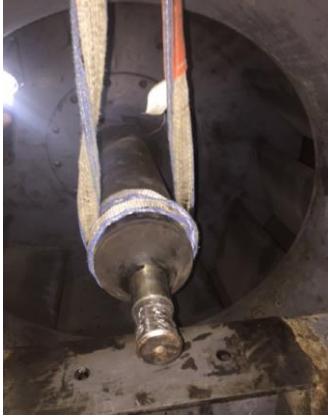
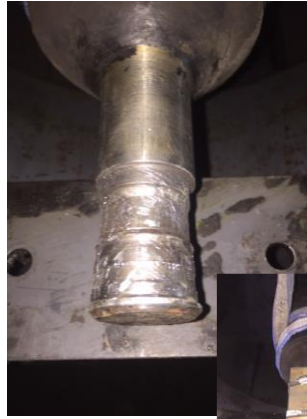
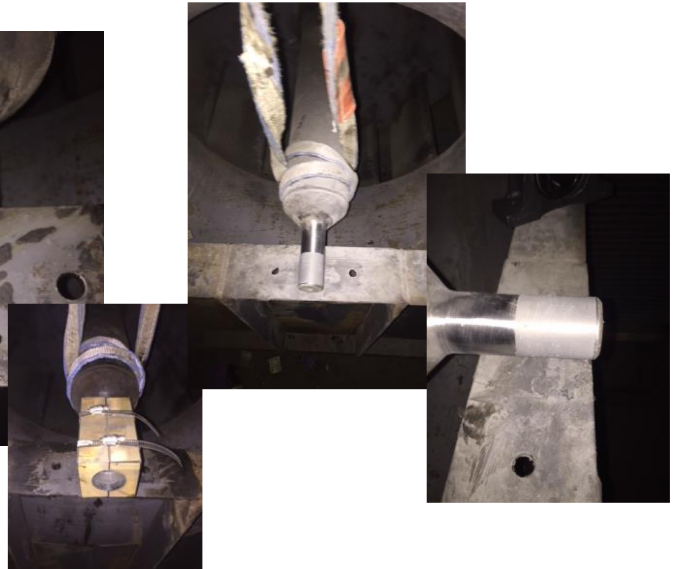
This Children's Hospital had a large shaft that was damaged with extreme wear. They were looking at a high-cost project that would take weeks or months to execute. Large holes in the walls or roof would have been created (and then fixed!) to lift out the damaged part and bring in a long-lead replacement. They consulted the USI Team for an unconventional solution to repair the shaft in place, saving time and money, instead of initiating a full replacement project.

The shaft was cleaned and degreased with [USI Universal Cleaner](#). The damaged area was abraded with an [MBX Bristle Blaster](#) to create a "clean and rough" finish with a 2.5 4mil anchor pattern. [Resimetal 101 Metal Repair Paste](#) was applied with a spatula. A form was clamped on to keep the shape and compress the material to prevent voids. [Resimac 904 Release Agent](#) keeps the paste from adhering to the form for easy removal. Emory cloth was used to smooth the surface and remove the parting lines after only 2 hours of set time. The shaft repair cured to full hardness and was ready to be put back into service in 72 hours.
