Shaft Repair on Rooftop

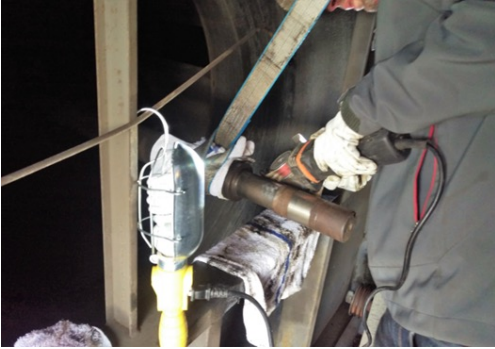
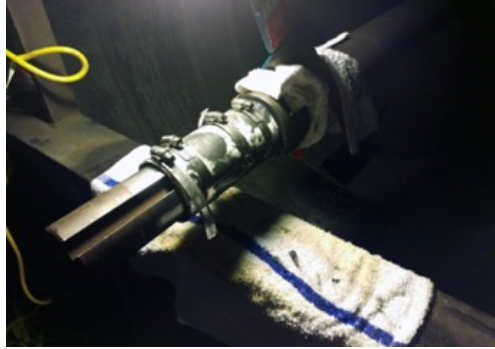
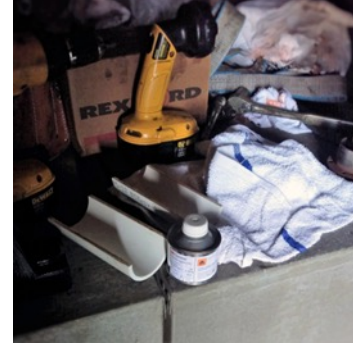
An automotive manufacturing company was hearing heavy vibration of a fan shaft on top of the roof, so they called Unconventional Solutions out for an emergency repair to fix a cracked shaft. The shaft was located in a penthouse HVAC building on the roof of a warehouse used for heating. The shaft was 6ft long, with a wear area 2"- 3" wide, by roughly 1/16"- 1/8" deep, caused from a bad bearing. A new shaft alone costs nearly \$2000 and would take 4 weeks to be delivered. A factor of 4 days of downtime and labor costs of 4 employees working 10+ hour days totaling approximately \$5000 to get the replacement shaft installed ready for service was also an issue.

As a turnkey project USI recommended using [RESIMETAL 101 Metal Repair Paste](#). The shaft was solvent cleaned with [USI Universal Cleaner](#), prepped with the [MBX Bristle Blaster](#) to achieve an anchor pattern of 2-3mils and SSPC-SP2 or SP3 standard then followed by another application of [USI Universal Cleaner](#) to remove any oil or debris.

[RESIMETAL 101 Metal Repair Paste](#) was properly mixed according to its Technical Data Sheet and formed with PVC pipe, lined with [USI Release Agent](#) and hose clamps to the wear area of the shaft. Heat was applied for a quicker overall cure time.

The project was completed in 6 hours and allowed to finish curing and was back in service within 48 hours.
