## Diesel Tank Exterior Refurbishment

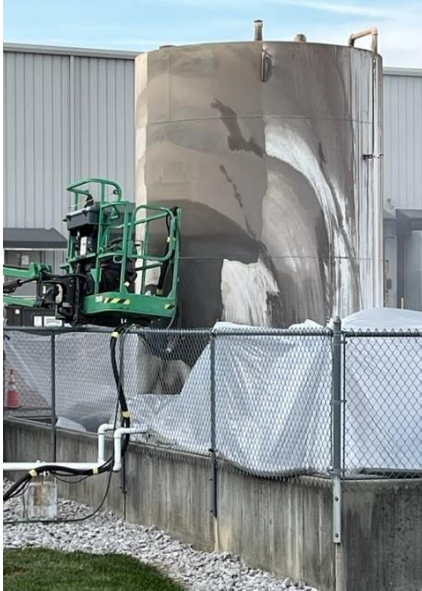
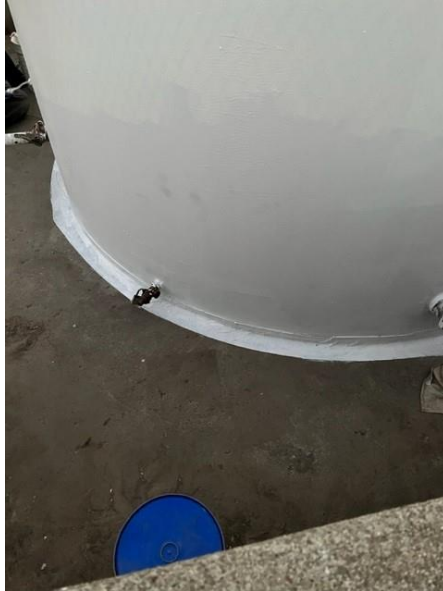
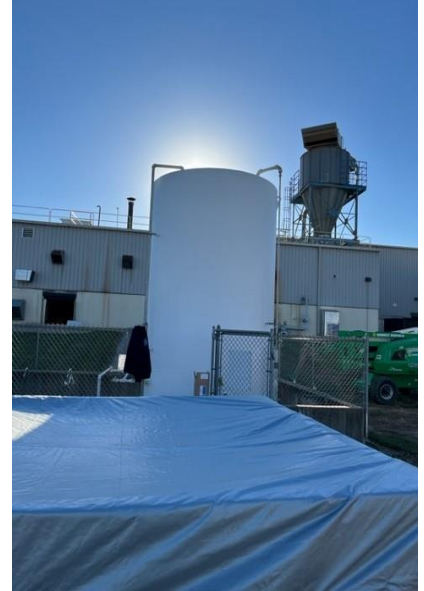
This existing coating on this steel tank was starting to crack and fail. The color had started to dull from being out in the elements.

Unconventional Solutions Inc. (USI) took a systematic approach to refurbish the tank:

- Surface Preparation:** USI began by abrasive blasting the entire surface of the tank.
- Primary Sealant Application:** Viscotaq ViscoSealant was applied to the tank chime area, where the steel tank met the concrete base.
- Protective Wrapping:** The application of Viscotaq ViscoSealant was followed by the installation of Viscotaq EZ Wrap over the entire tank chime area. This wrap formed a robust protective seal around the tank chime, safeguarding the area against water ingress and corrosion.
- Final Coating:** To complete the refurbishment, USI applied two coats of Resichem 555 in white to the entire surface of the tank. This product was specifically chosen for its high UV resistance, protecting the tank from the damaging effects of sunlight, and its superior corrosion resistance properties.
