Heat Exchanger Room Floor

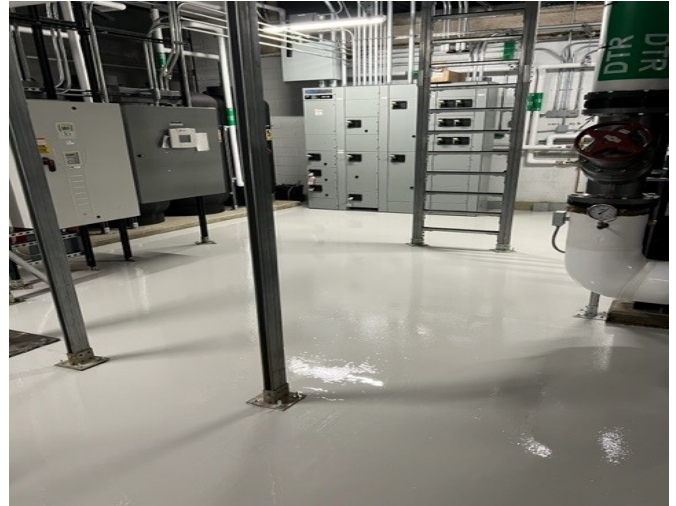
Our client wanted to renovate their heat exchanger room floor. They removed several blocks of concrete from the flooring, added new piping and machinery and wanted the entire floor recoated to enhance the aesthetics of the room as well as adding some grit to the flooring to help alleviate slips and falls.

The USI crew came in and started to scarify the existing floor and old coating.

After thoroughly cleaning and vacuuming the floor, we repaired any damaged or cracked areas using our [USI Epoxy Mortar Patch Kit](#).

We then applied one coat of the [USI Flexible Broadcast Primer](#).

We then applied 2 coats of [USI High Build Epoxy Color Coat](#) and according to our client's specifications mixed in [USI White Aluminum Oxide](#) to provide a slip free environment.
