Auto Plant Striping Pit Repair

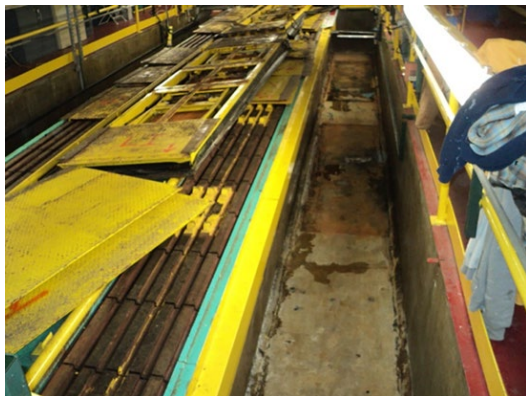
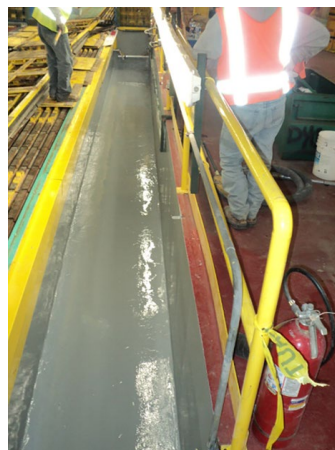
The striping pit at this auto plant – the area cars get their racing stripes - was accumulating damage from hydrostatic pressure.

The plant was built on a wetland, which contributed to persistent groundwater penetration. Numerous treatments were applied over the years, but nothing was keeping the water out and protecting the concrete.

USI recommended Resichem 572 Concrete Seal CWC, a membrane that prevented moisture intrusion into the pit. Included in this solution were USI Moisture Barrier and USI High-Build Epoxy.

RESICHEM 572 Concrete Seal CWC, can hold back up to 140 PSI of hydrostatic pressure, and is the model solution for basements, floors, walls, and ceilings that are fighting the battle with moisture infiltration.
