Nitrogen Line Pipe Rehabilitation

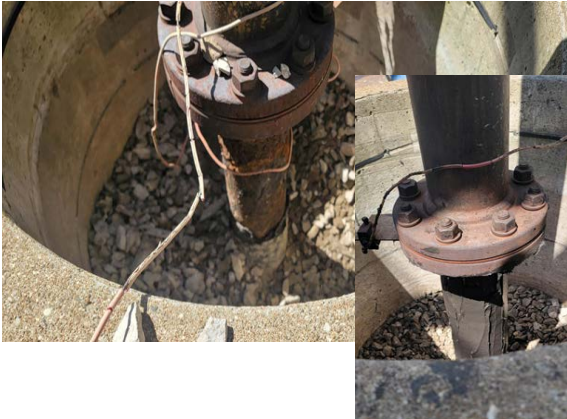
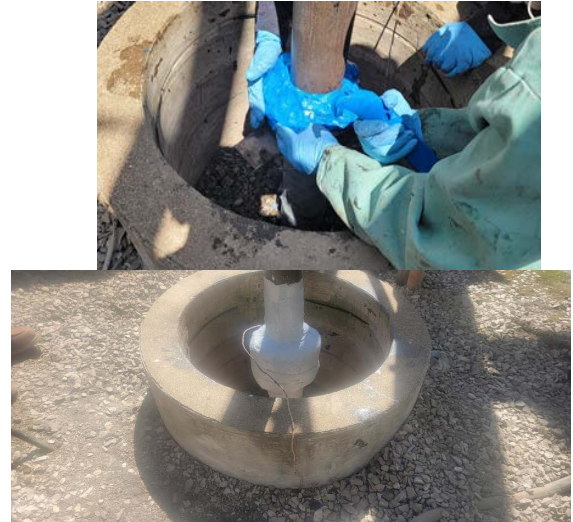
This 6" 180-psi Nitrogen Line that was suffering from severe corrosion supplied a key chemical manufacturer.

After proper SSPC-SP-1 and SSPC-SP-2 prep, **Resimetal 302 Repair Cement** was used to fill in pitted steel. **Resimetal 301 Fiberglass Resin**, along with **Resimac 703 Glass Tape** built a pipe rehabilitation system giving hoop strength and created a pipe over a pipe incase anything fails in the future.

Resichem 501 CRSG was used to coat the entire flange and pipe to provide a robust corrosion protection system and to prevent further degradation. The flange was in good condition so **Viscotag Mastic** and **Denso EZ Wrap** manufactured by Denso were recommended for corrosion protection on this area.
