## Power Plant Roof Repair

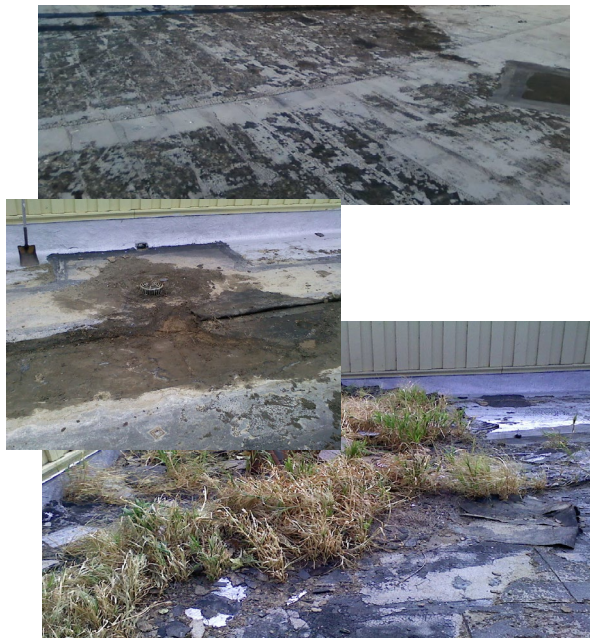
The roof on this major power plant was neglected as the plant was scheduled for closure in three to five years.

Tearing off and putting on a new roof was not financially feasible. The plant did not want to go another year without repairing all the leaks because of safety issues and possible freezing during the winter.

Weeds and trees were removed and the roof was thoroughly cleaned, free of dust and debris.

Next, we applied one grey coat of **ResiChem 559 BP Primer** for Bituminous Roofs.

Then we applied two white coats of **550 WR Membrane**. Since the repair, the plant has had several severe rainfalls with no leaks.
